WHITE MESA URANIUM MILL

LICENSE RENEWAL APPLICATION

STATE OF UTAH RADIOACTIVE MATERIALS LICENSE No. UT1900479

**Volume 3 of 5
(License Renewal Application)
(Appendices J-O)**

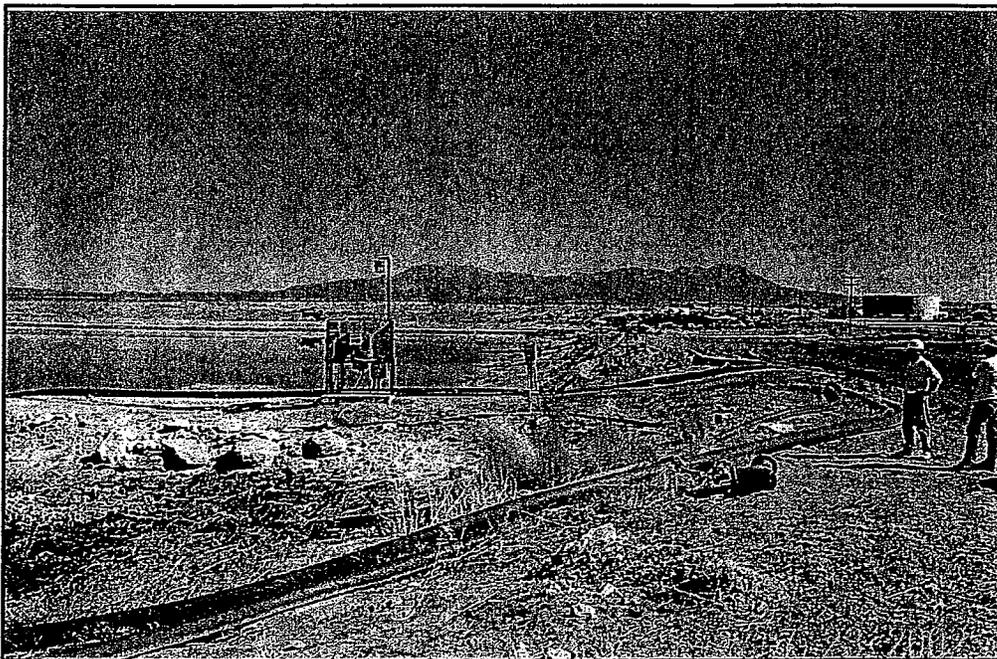
Photo 2. Looking north along the east side of Cell 1-I. Note that the ground elevation is approximately the same as the dike elevation.

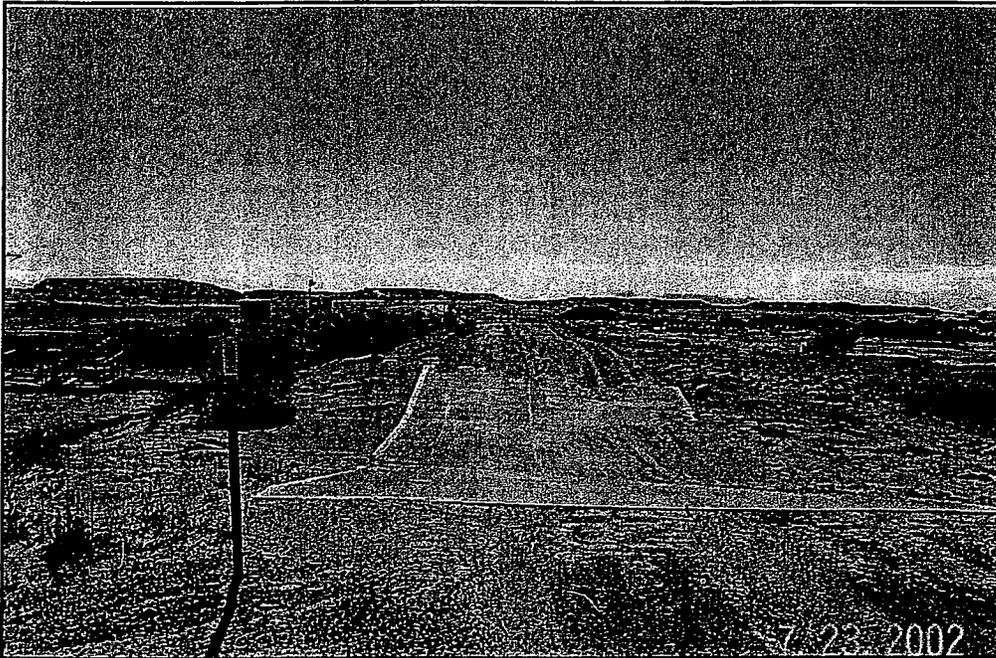
Photo 6. The concrete spillway section located near center of Dike 2 appears to be in good condition. Cell No. 2 is on the left in photo and Cell No. 3 is on the right.

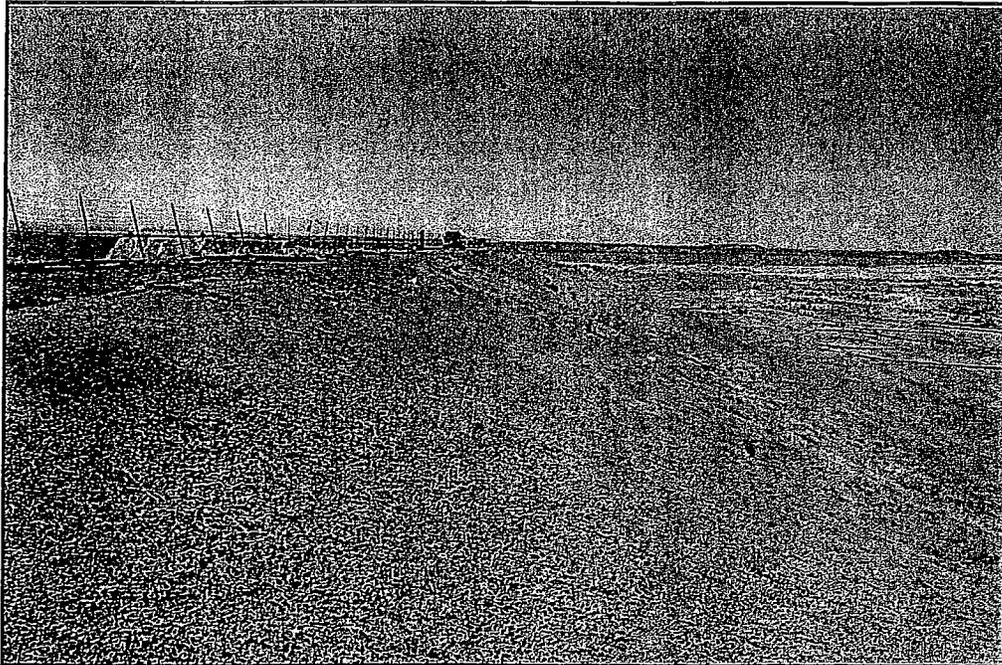
Photo 9. Looking south along the downstream slope of Dike 4A-W. Note the uniform slope, minimal vegetation, and lack of significant erosion.

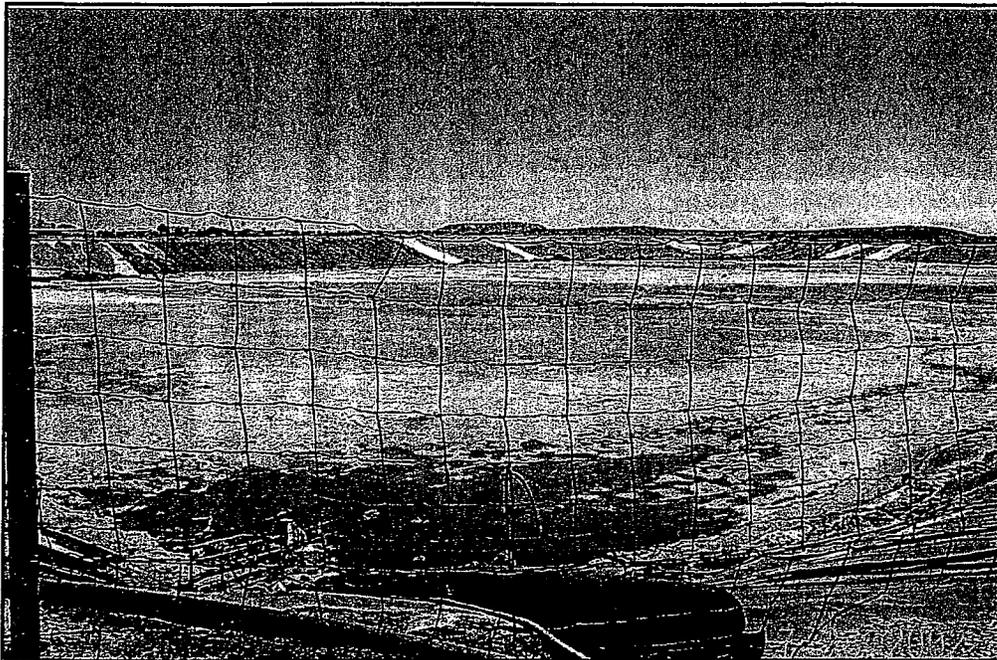
Photo 10. Looking across Cell 4-A from southwest corner. Note solution in foreground which is pumped back to Cell No. 3 as crystals are dissolved. Also, note damaged HDPE liner around the interior of the cell.

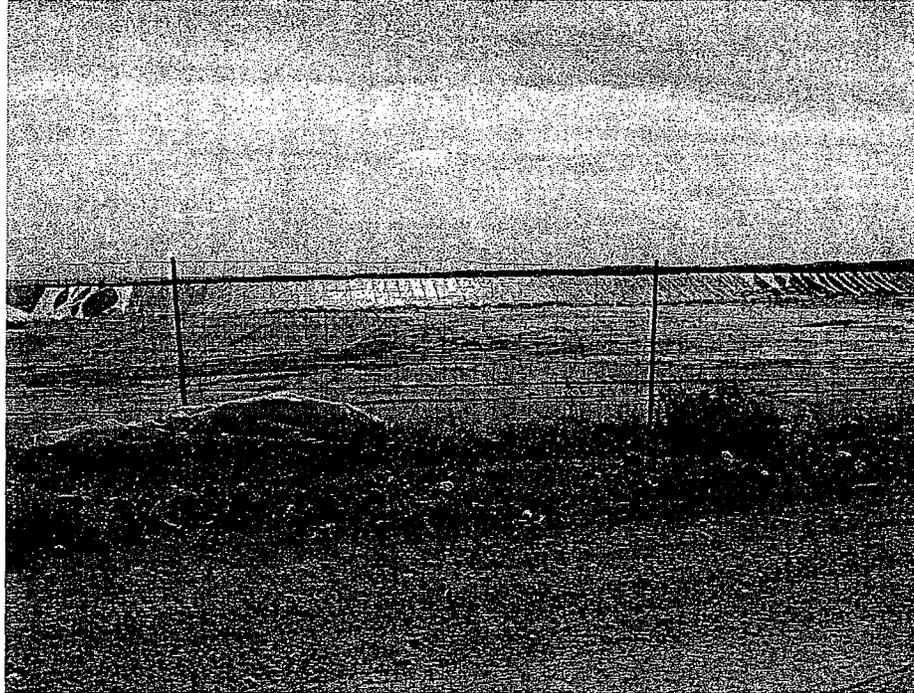
Figure 11: March 22, 2005: Same as Figure 10. On the left and right of the embankment, the liner can be seen to be ripped.

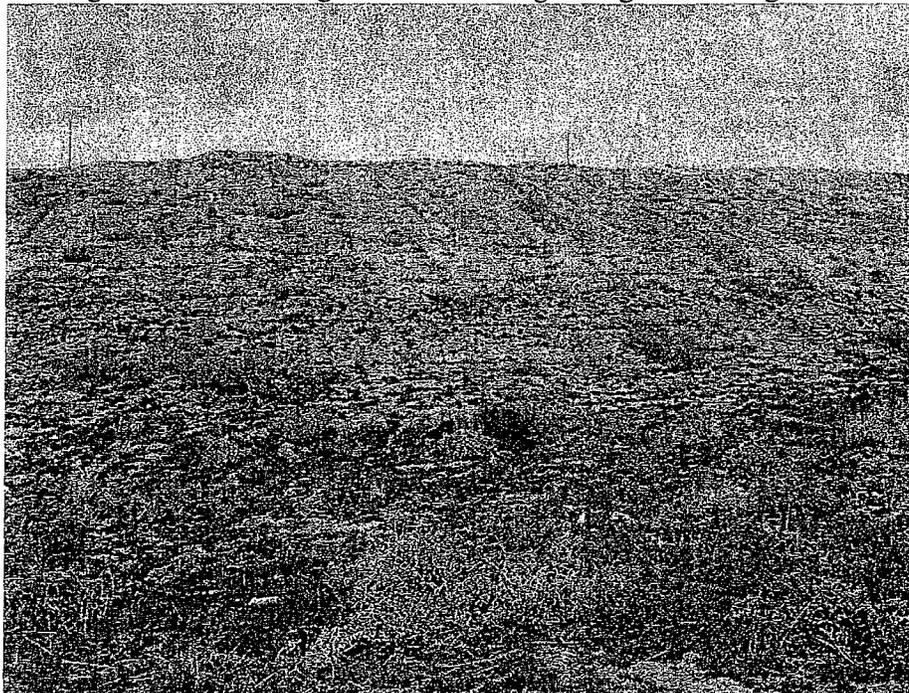
Figure 12: March 22, 2005: Cell 4A downslope embankment viewed from the south. Sage brush and short grass can be seen growing in the foreground.

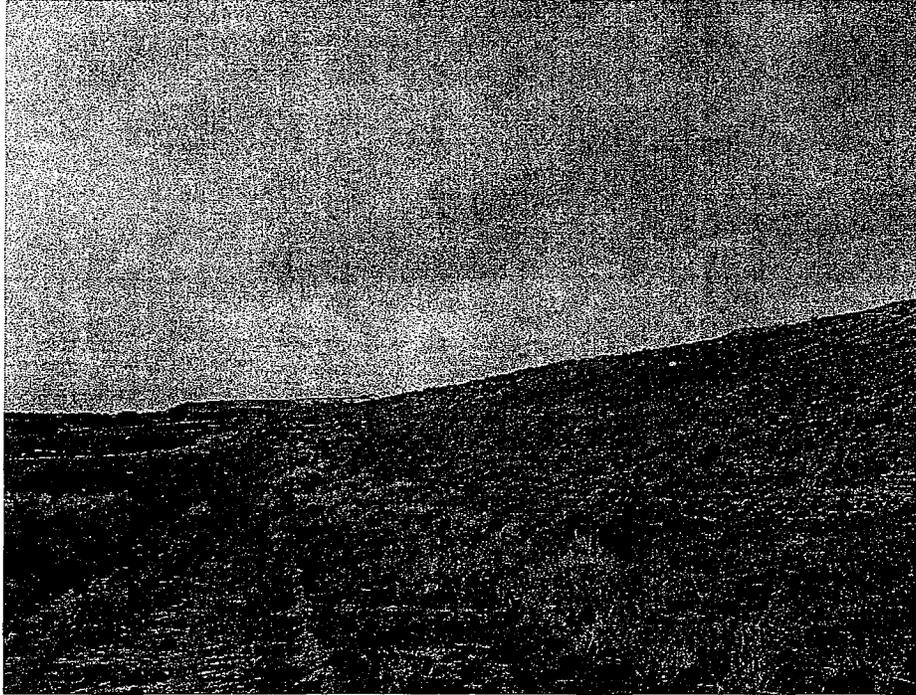
Figure 9: March 22, 2005: Cell 3 downslope embankment viewed from the east. Sage brush and short grasses are growing on the slope.

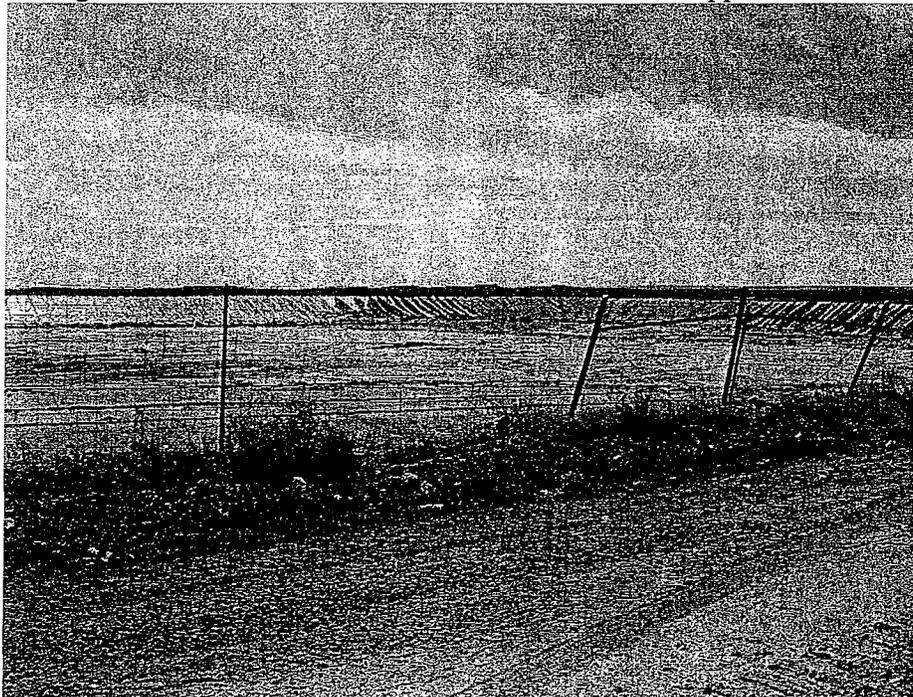
Figure 10: March 22, 2005: Cell 4A viewed from north embankment. In the center and right of the embankment, the liner can be seen to be ripped.
