DEPARTMENT OF ENVIRONMENTAL QUALITY  
DIVISION OF RADIATION CONTROL

## MEMORANDUM

SUBJECT: International Uranium Corporation White Mesa Uranium Tailings Facility:  
Engineering Design and As-Built Reports; **Staff Findings, Conclusions, and  
Recommendations.**

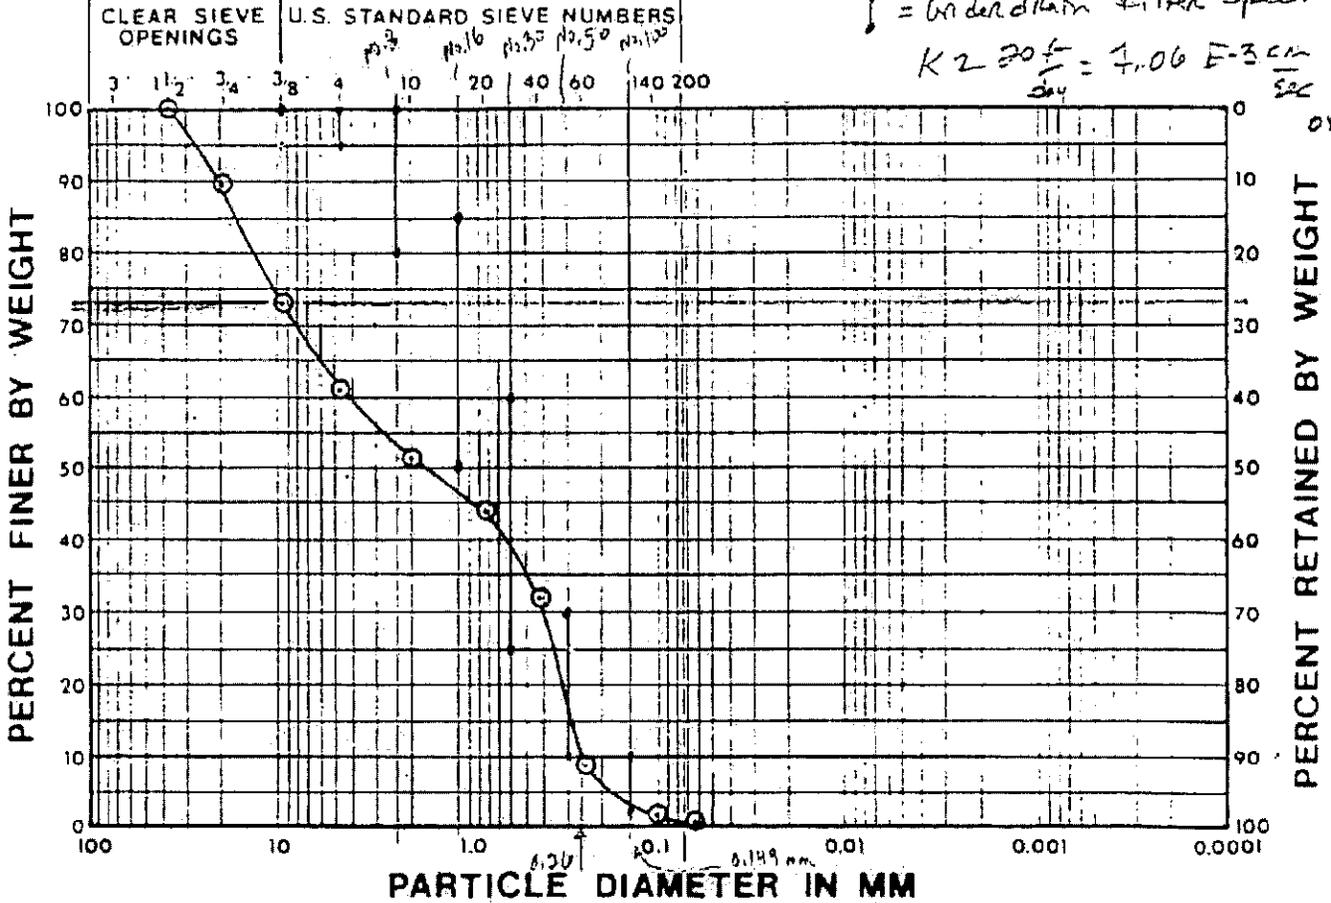
**HYDROMETER ANALYSIS**

↓ = "Under drain" Filter Spec.  
 $K = \frac{20 \text{ ft}}{\text{day}} = 1.06 \text{ E-3 cm/sec}$
