**Utah Department of Environmental Quality
 Division of Water Quality
 TMDL Section
 Otter Creek Watershed TMDL**

1993-1998 Field Evaluations and Progress Report
OTTER CREEK
May 14, 1999

OTTER CREEK

May 14, 1999

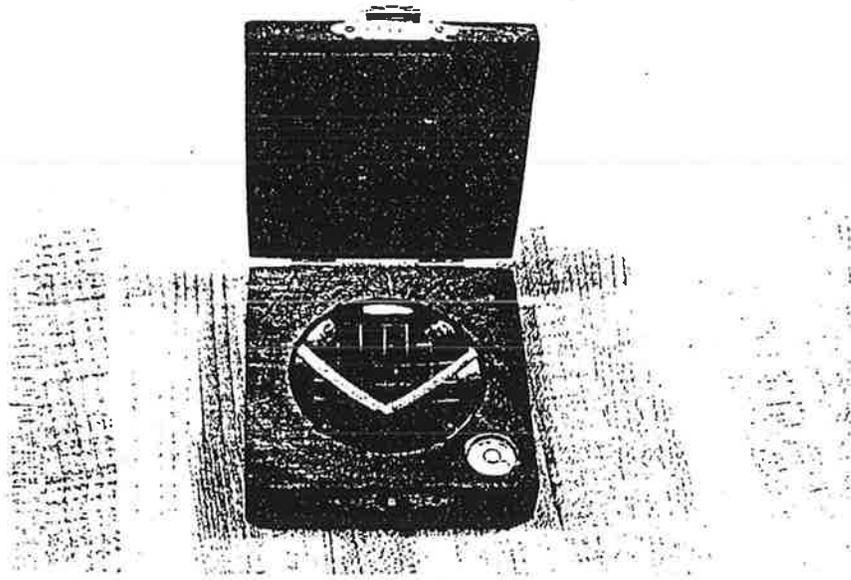
Figure 4.2 The concave spherical densiometer Model B (Platts, 1987).

During the field studies of 1993-1998 conducted in Otter Creek, Little Bear River, Beaver River, and Mill Creek, data was collected for selected reaches for canopy density and solar input to the stream surface. Canopy density data was collected using a spherical canopy densiometer (convex) after a protocol suggested by Platts, et. al. (1987). The densiometer consists of a convex mirror surface with etched grid (37 intersections) that reflects vegetation and other obstructions above the stream channel. Due to the curved reflecting surface, the observed area at any given point will result in an overlap of observed area. Modifications suggested by Strichler (1959) were adopted which reduces the observed grid intersections in any of four cardinal directions to 17. A right angle is taped on the mirror to define the 17 intersection points.

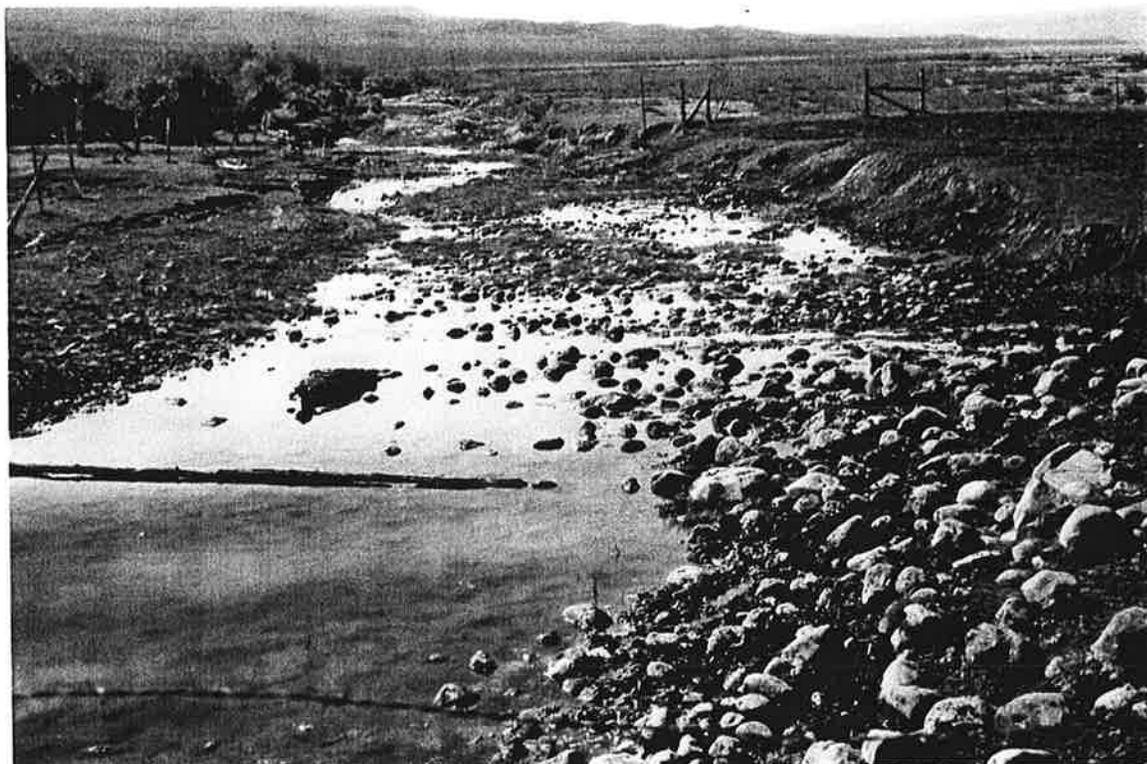
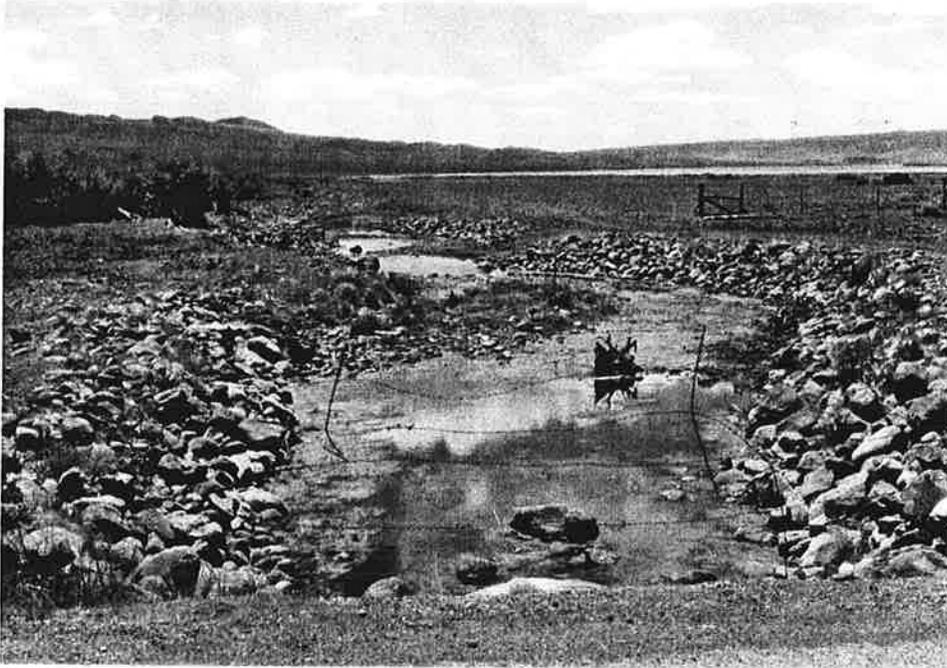
Photo 1. Pretreatment 1990, from culvert facing downstream.

Photo 2. Pretreatment 1991, from culvert facing downstream.

Photo 3. Mid-implementation 1993, from culvert facing downstream.

Photo 4. Post treatment 1998, from culvert facing downstream. The sequence of photos 1-4 show an improvement in this site over time.

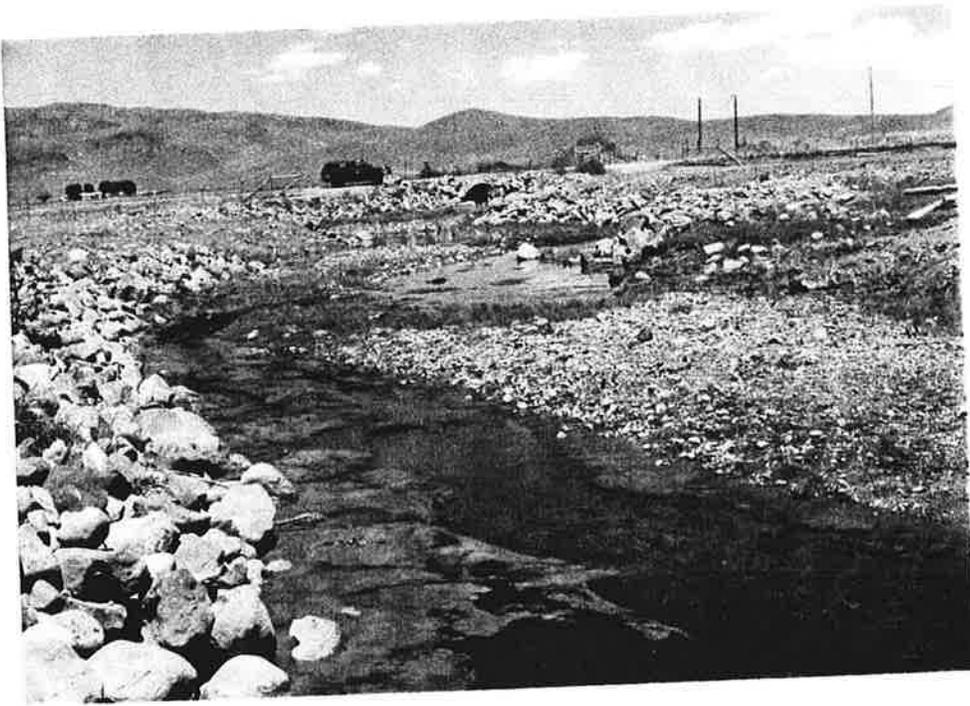
Photo 5. Mid-implementation 1993, G0 facing upstream.

Photo 6. Post treatment 1998, G0 facing upstream (same location as photo 5). Notice the point bar development and increase in bank vegetation.

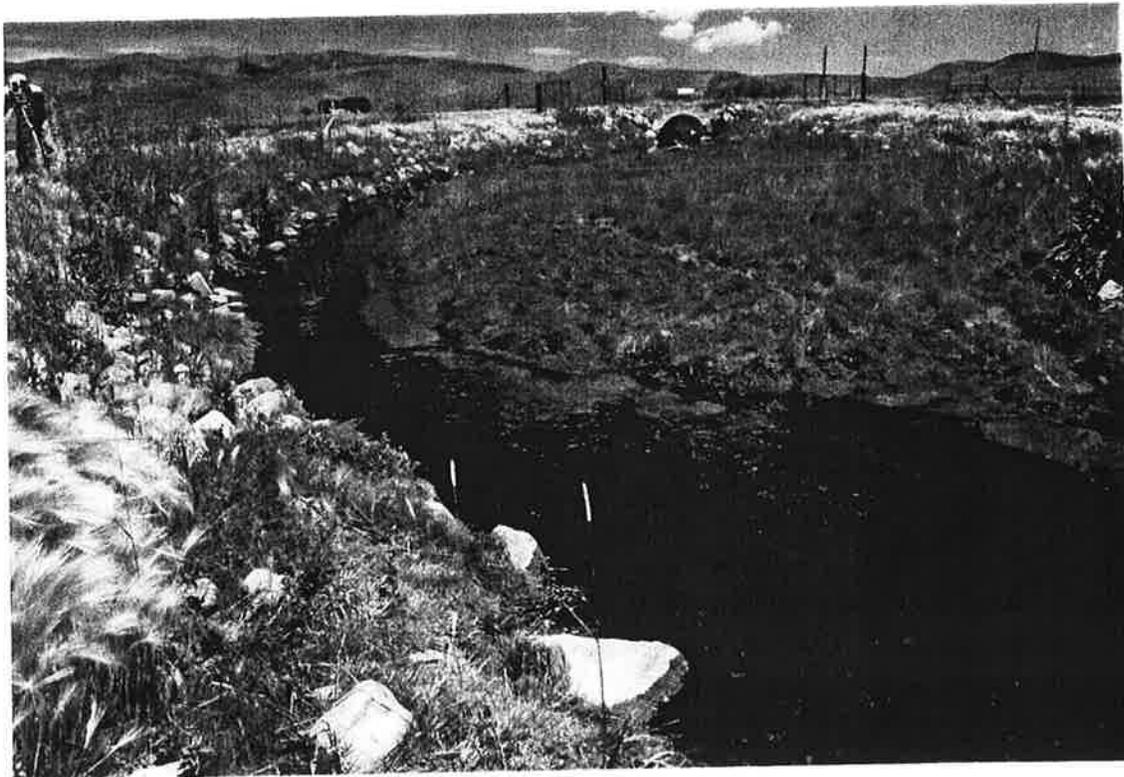
Photo 7. Mid-implementation 1993, G1 and G2 facing upstream.

Photo 8. Post treatment 1998, G1 and G2 facing upstream (same location as photo 7). Notice the point bar development and increase in bank vegetation.

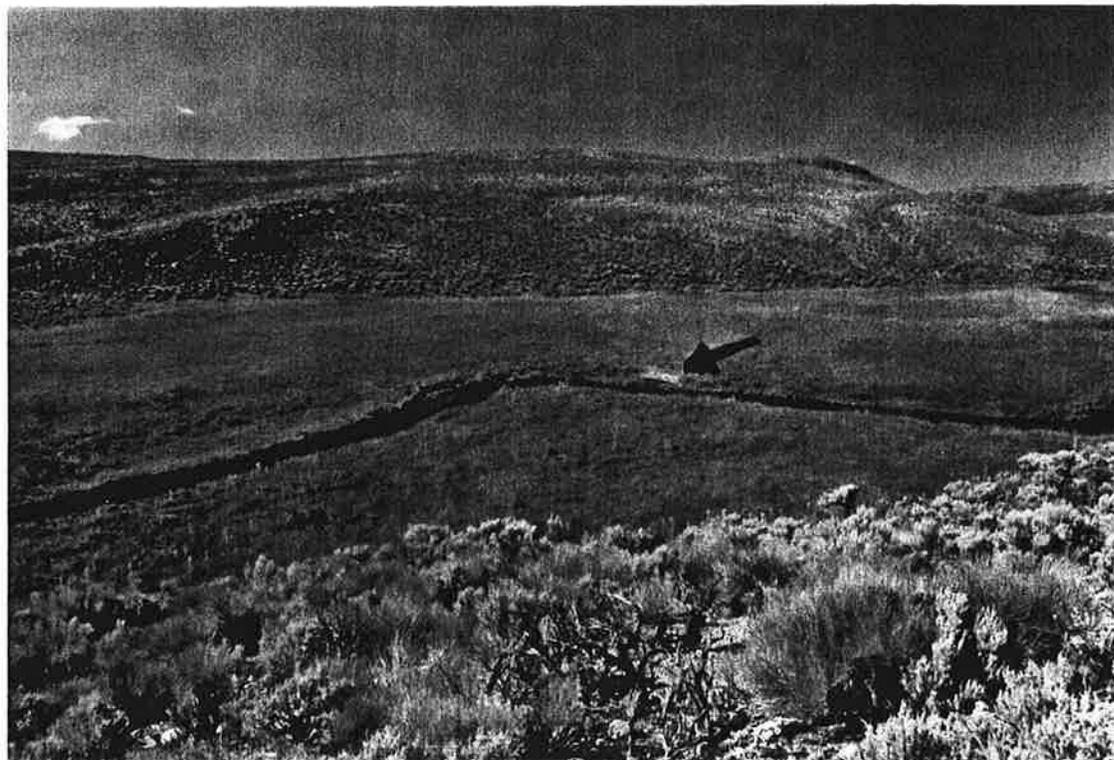
Photo 9. Planview 1993, downstream section of site. Arrow indicates a reference point between photo 9 and 10.

Photo 10. Planview 1998, downstream section of site. Trend at this site, based on the riparian evaluation, shows improvement. But, some raw and eroding bank still occurs just above the arrow reference point.

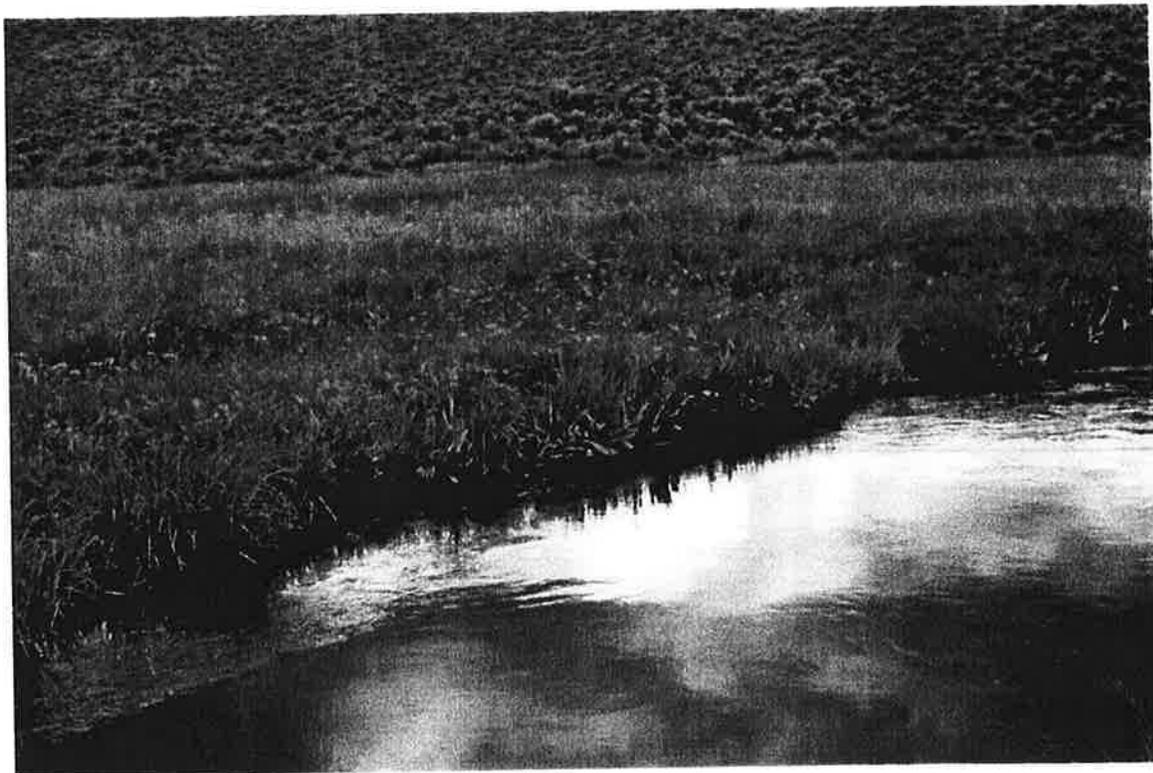
Photo 11. Greenline survey endpoint 1993.

Photo 12. Greenline survey endpoint 1998 (same location as photo 11) Comparing the far bank, there is improvement in streambank vegetation.

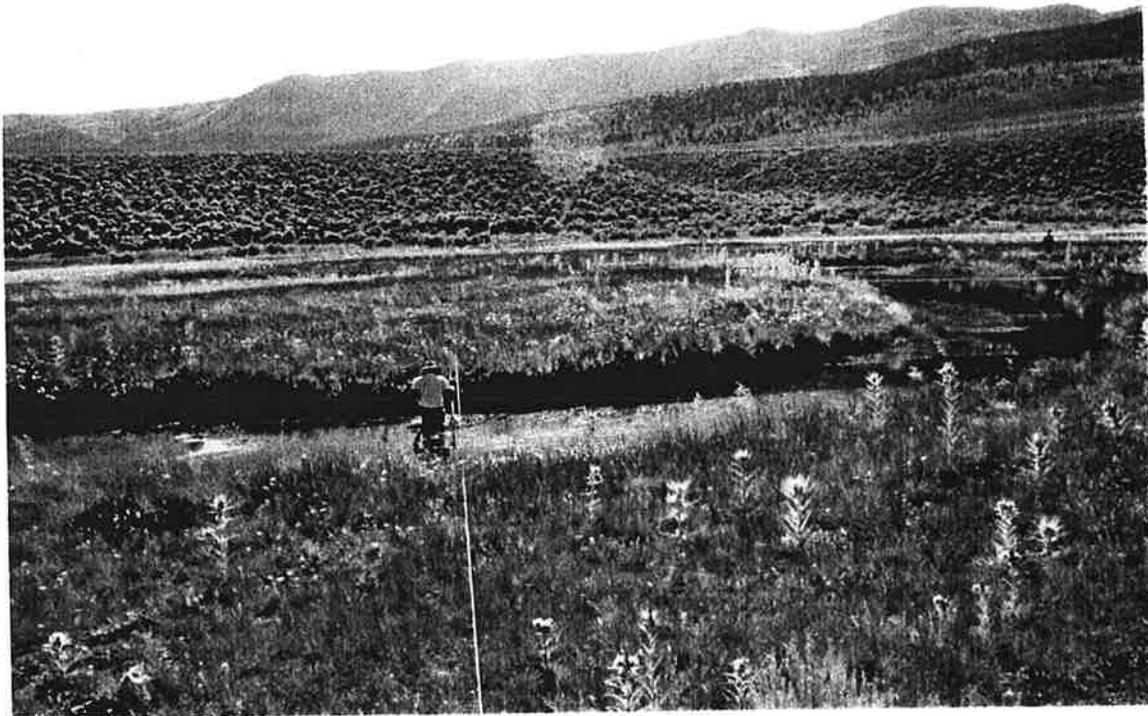
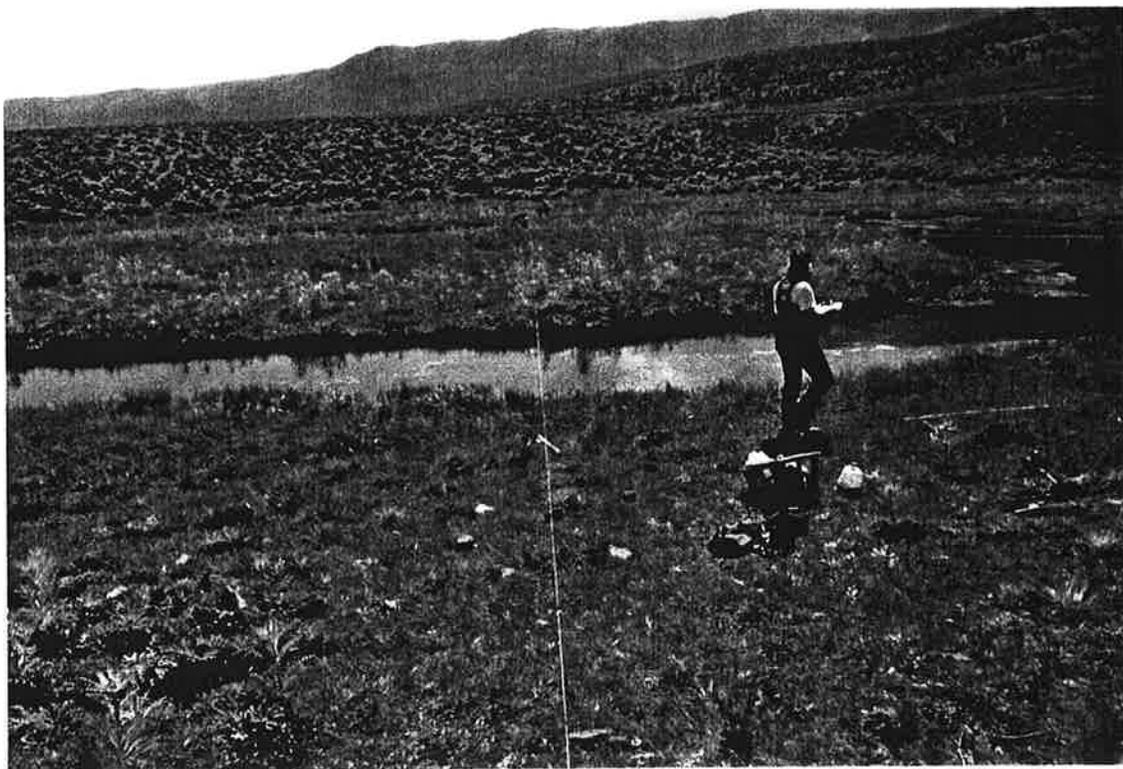
Photo 13. 1994, Transect G0a, b, c from West bank facing East bank.

Photo 14. 1998, Transect G0a, b, c (same location as photo 13). No significant changes observed.

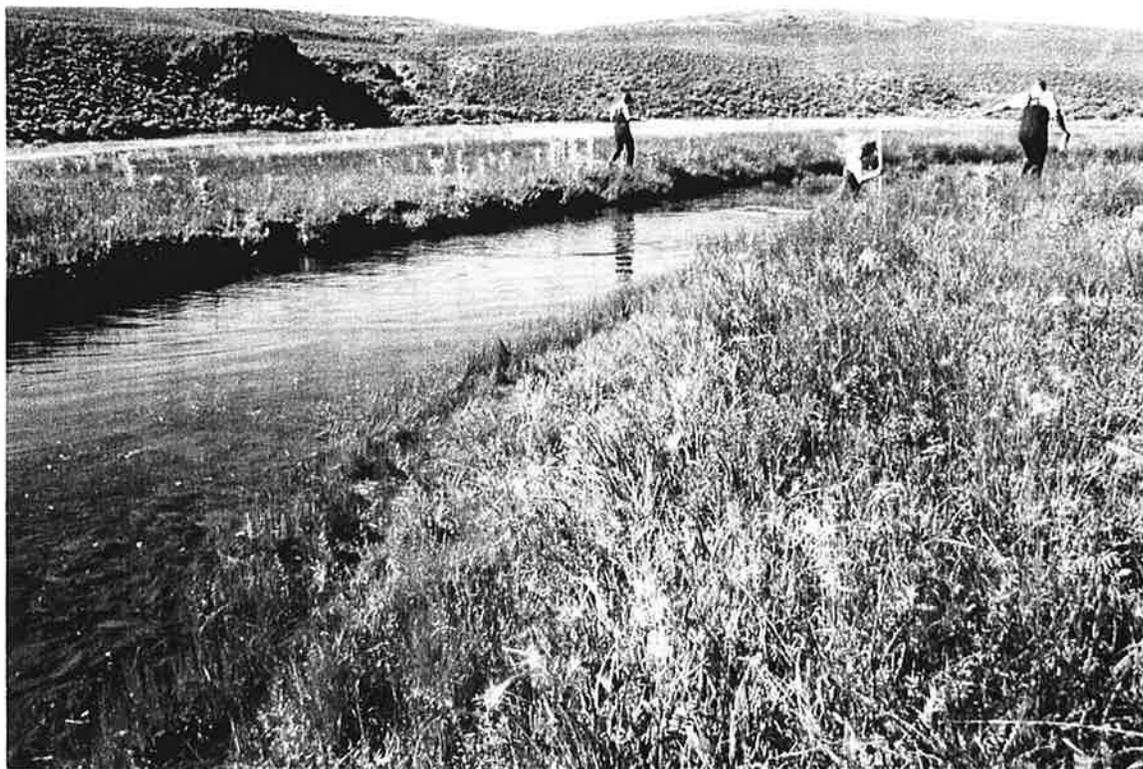
Photo 15. 1994, Transect G0b.

Photo 16. 1998, Transect G0b (same location as photo 15). No significant changes observed.
