Temperature Total Maximum Daily Load (TMDL) for Upper Nine Mile Creek Watershed

Prepared for:
US Environmental Protection Agency, Region 8

Prepared by:
Utah Department of Environmental Quality
Division of Water Quality
Sandy Wingert, Project Manager
Ben Holcomb, Technical Support
Carl Adams, Project Supervisor

Waterbody ID	14060005-002
Location	Carbon and Duchesne Counties, Utah
Pollutant of Concern	Temperature
Impaired Beneficial Use	Class 3A: Protected for cold water species of game fish and other cold water aquatic life
Current Loading Loading Capacity (TMDL) Load Reduction	835,045.6 kWh/day 231,637.6 kWh/day 603,408 kWh/day (72.3%)
Wasteload Allocation Load Allocation Margin of Safety	0 kWh/day 231,637.6 kWh/day Implicit
Defined Targets/Endpoints	<ol style="list-style-type: none"> 1. Water quality target of 20° C 2. Total maximum load of 231,637.6 kWh/d 3. 36% increase in riparian shade
Implementation Strategy	Stormwater, grazing, and riparian best management practices
This document is identified as a TMDL for waters of Upper Nine Mile Creek watershed and is submitted under §303d of the Clean Water Act to U.S. EPA for review and approval.

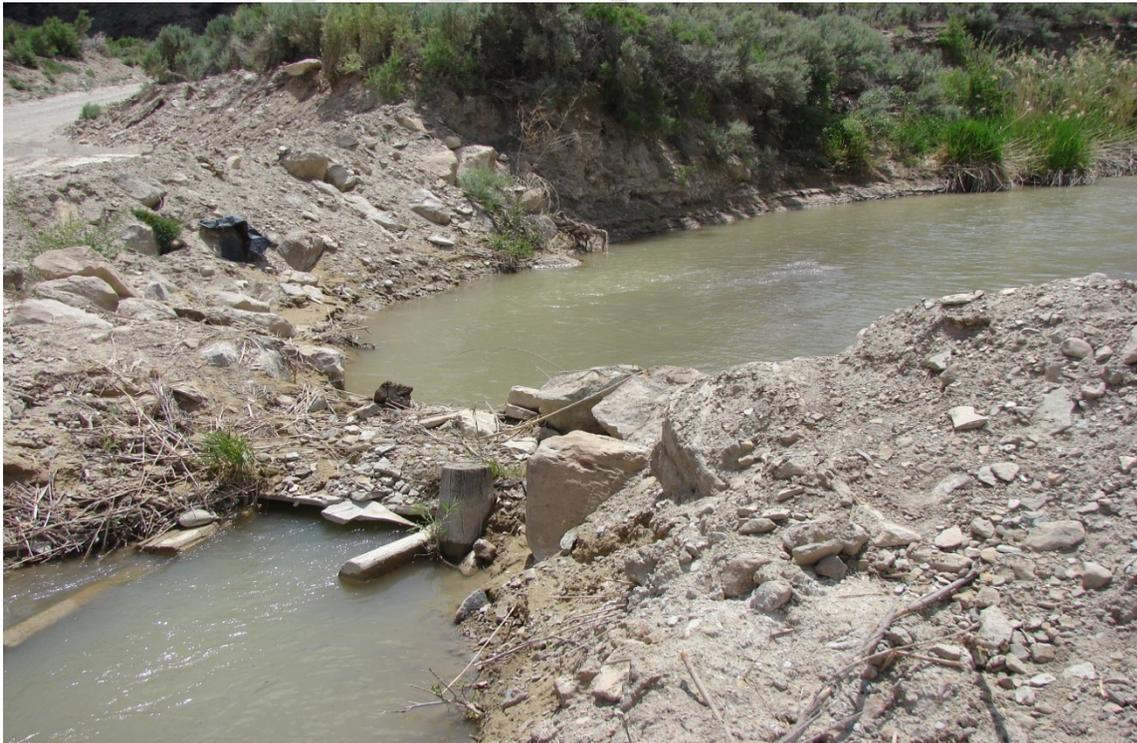
Figure 35. Nine Mile Creek Dammed for Water Withdrawal for Energy Development.

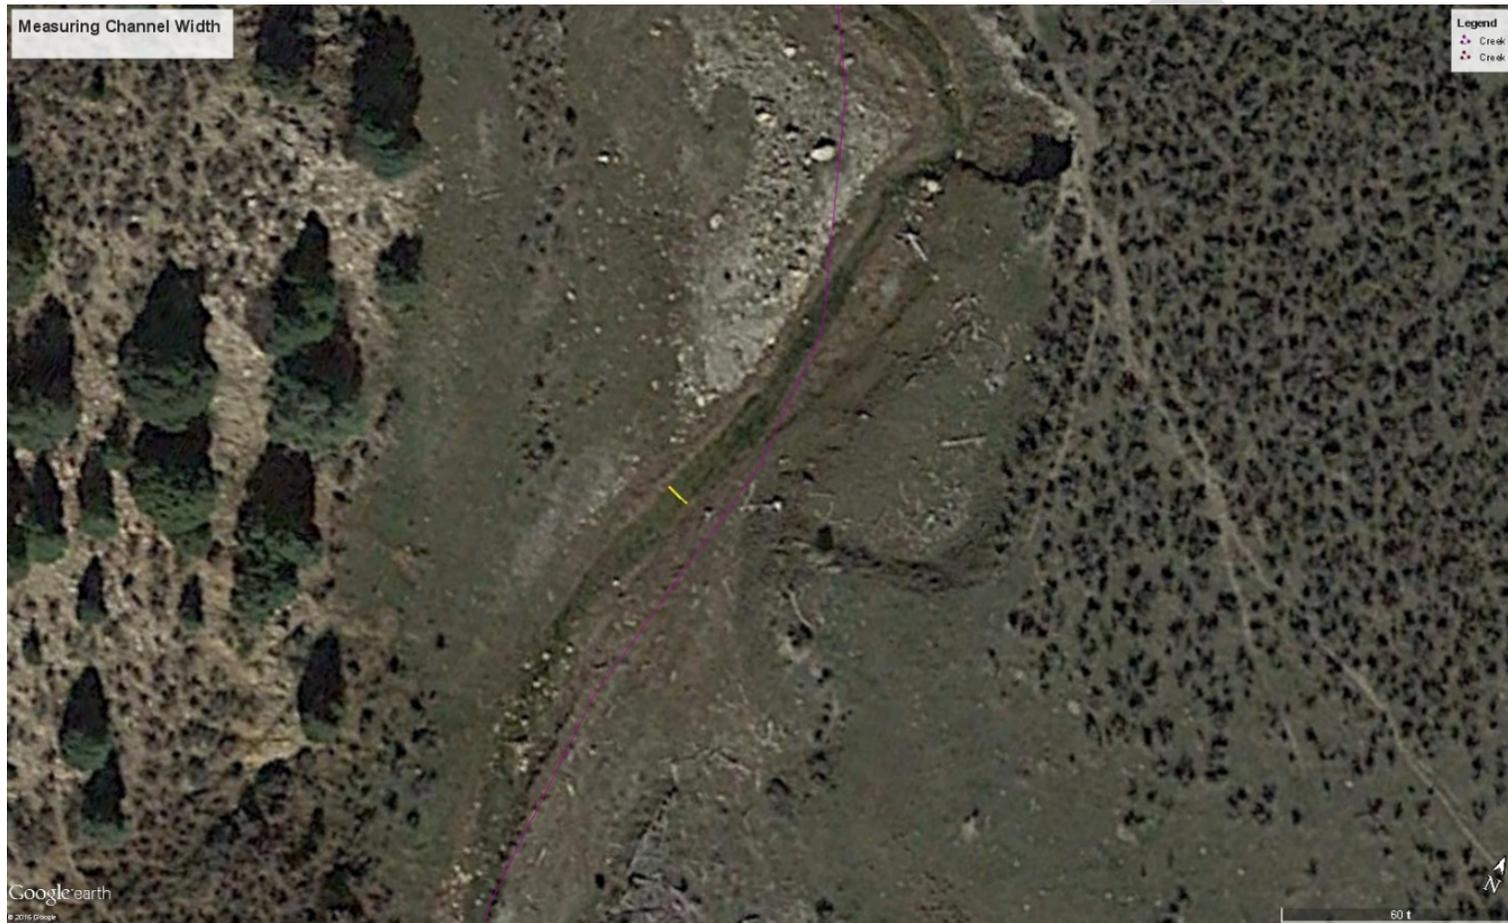
Figure 40. Example of Collecting Stream Widths (yellow hash mark) in Google Earth Pro. This example has an estimated 2.05m width.
