CONSTRUCTION REPORT
SECOND PHASE
TAILINGS MANAGEMENT SYSTEM

White Mesa Uranium Project
Energy Fuels Nuclear, Inc.
March, 1983

SUA-1358, Docket 40-8681

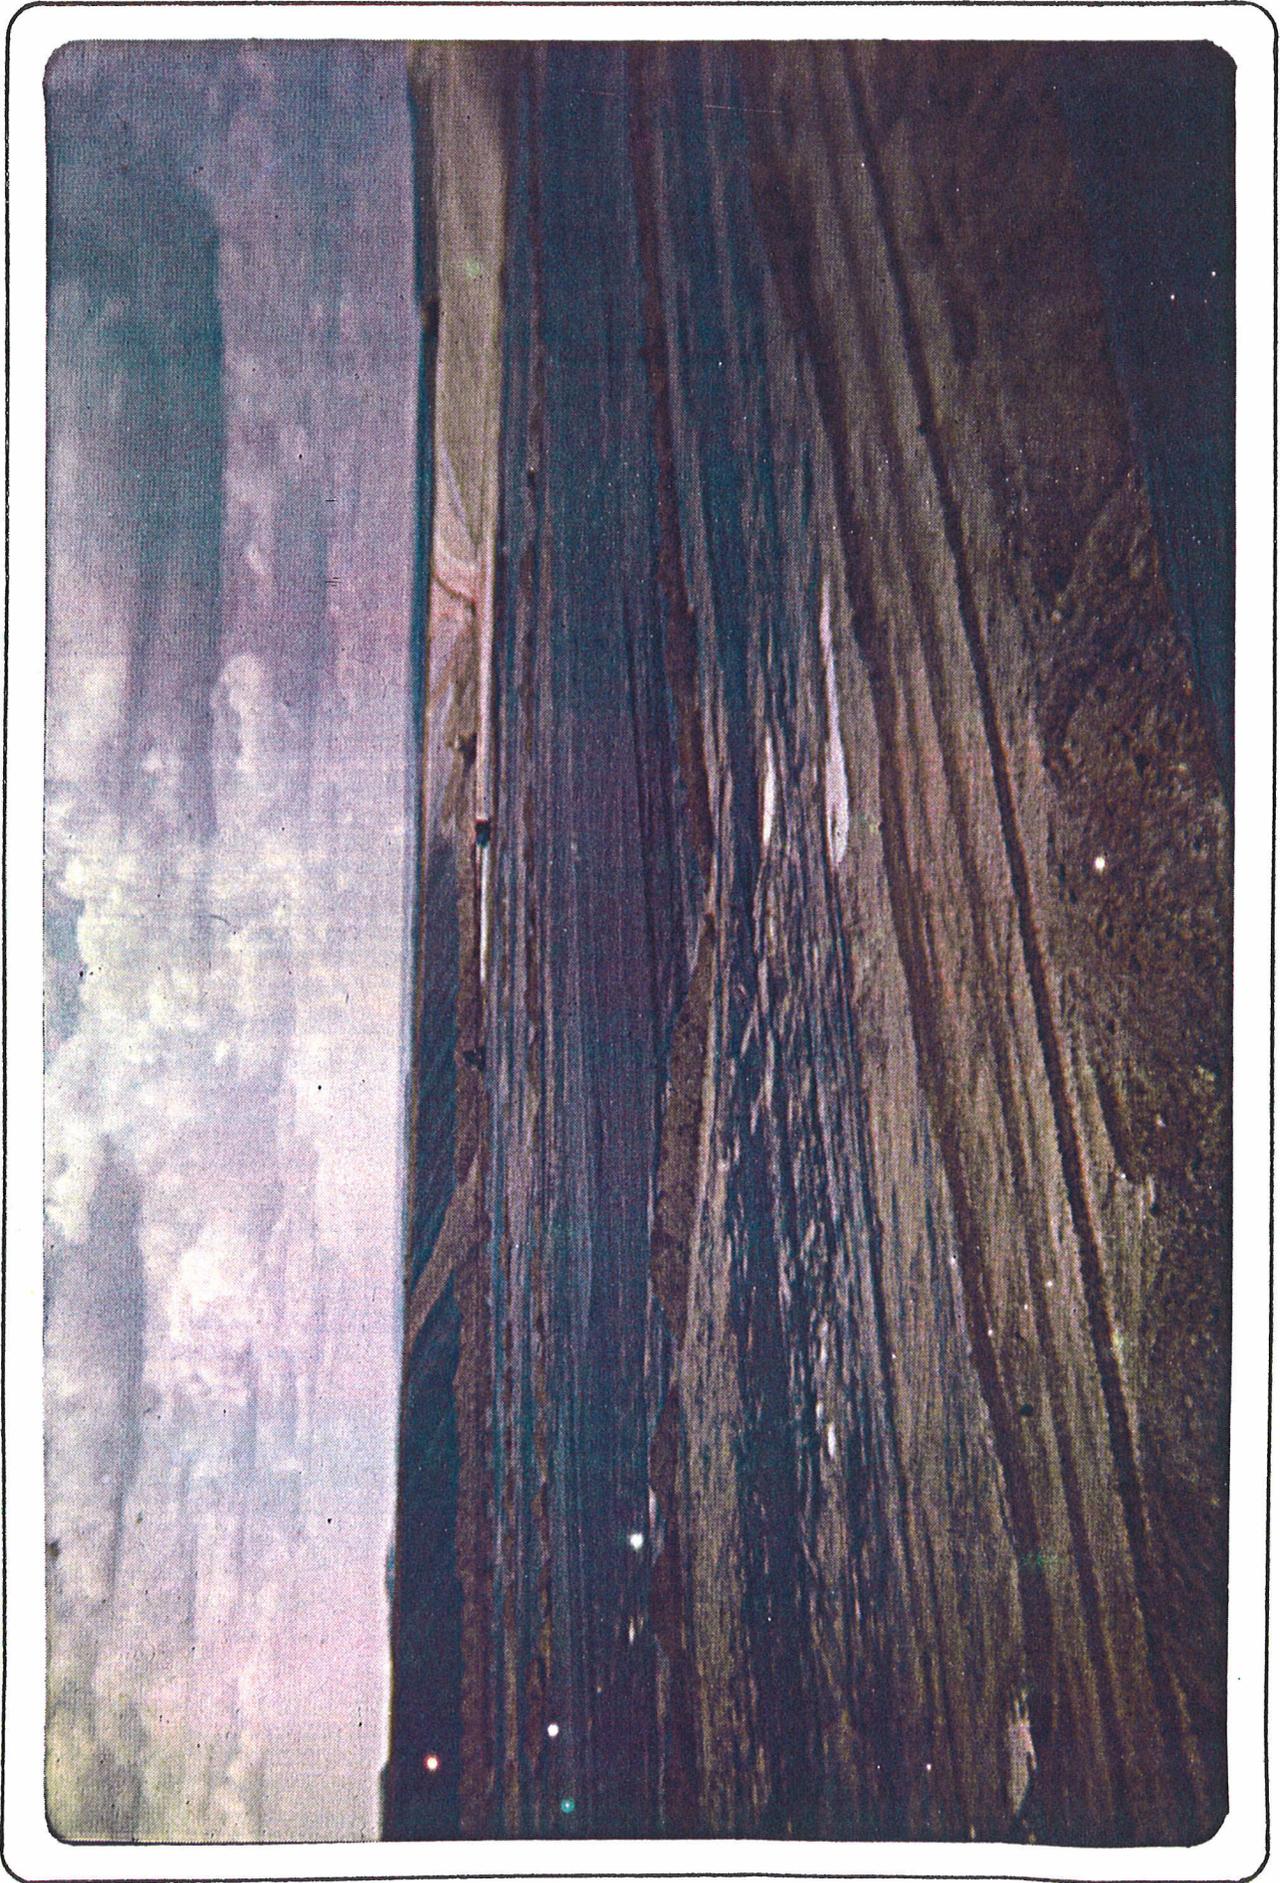
Cell 3 - Liner Installation and Cover Operations

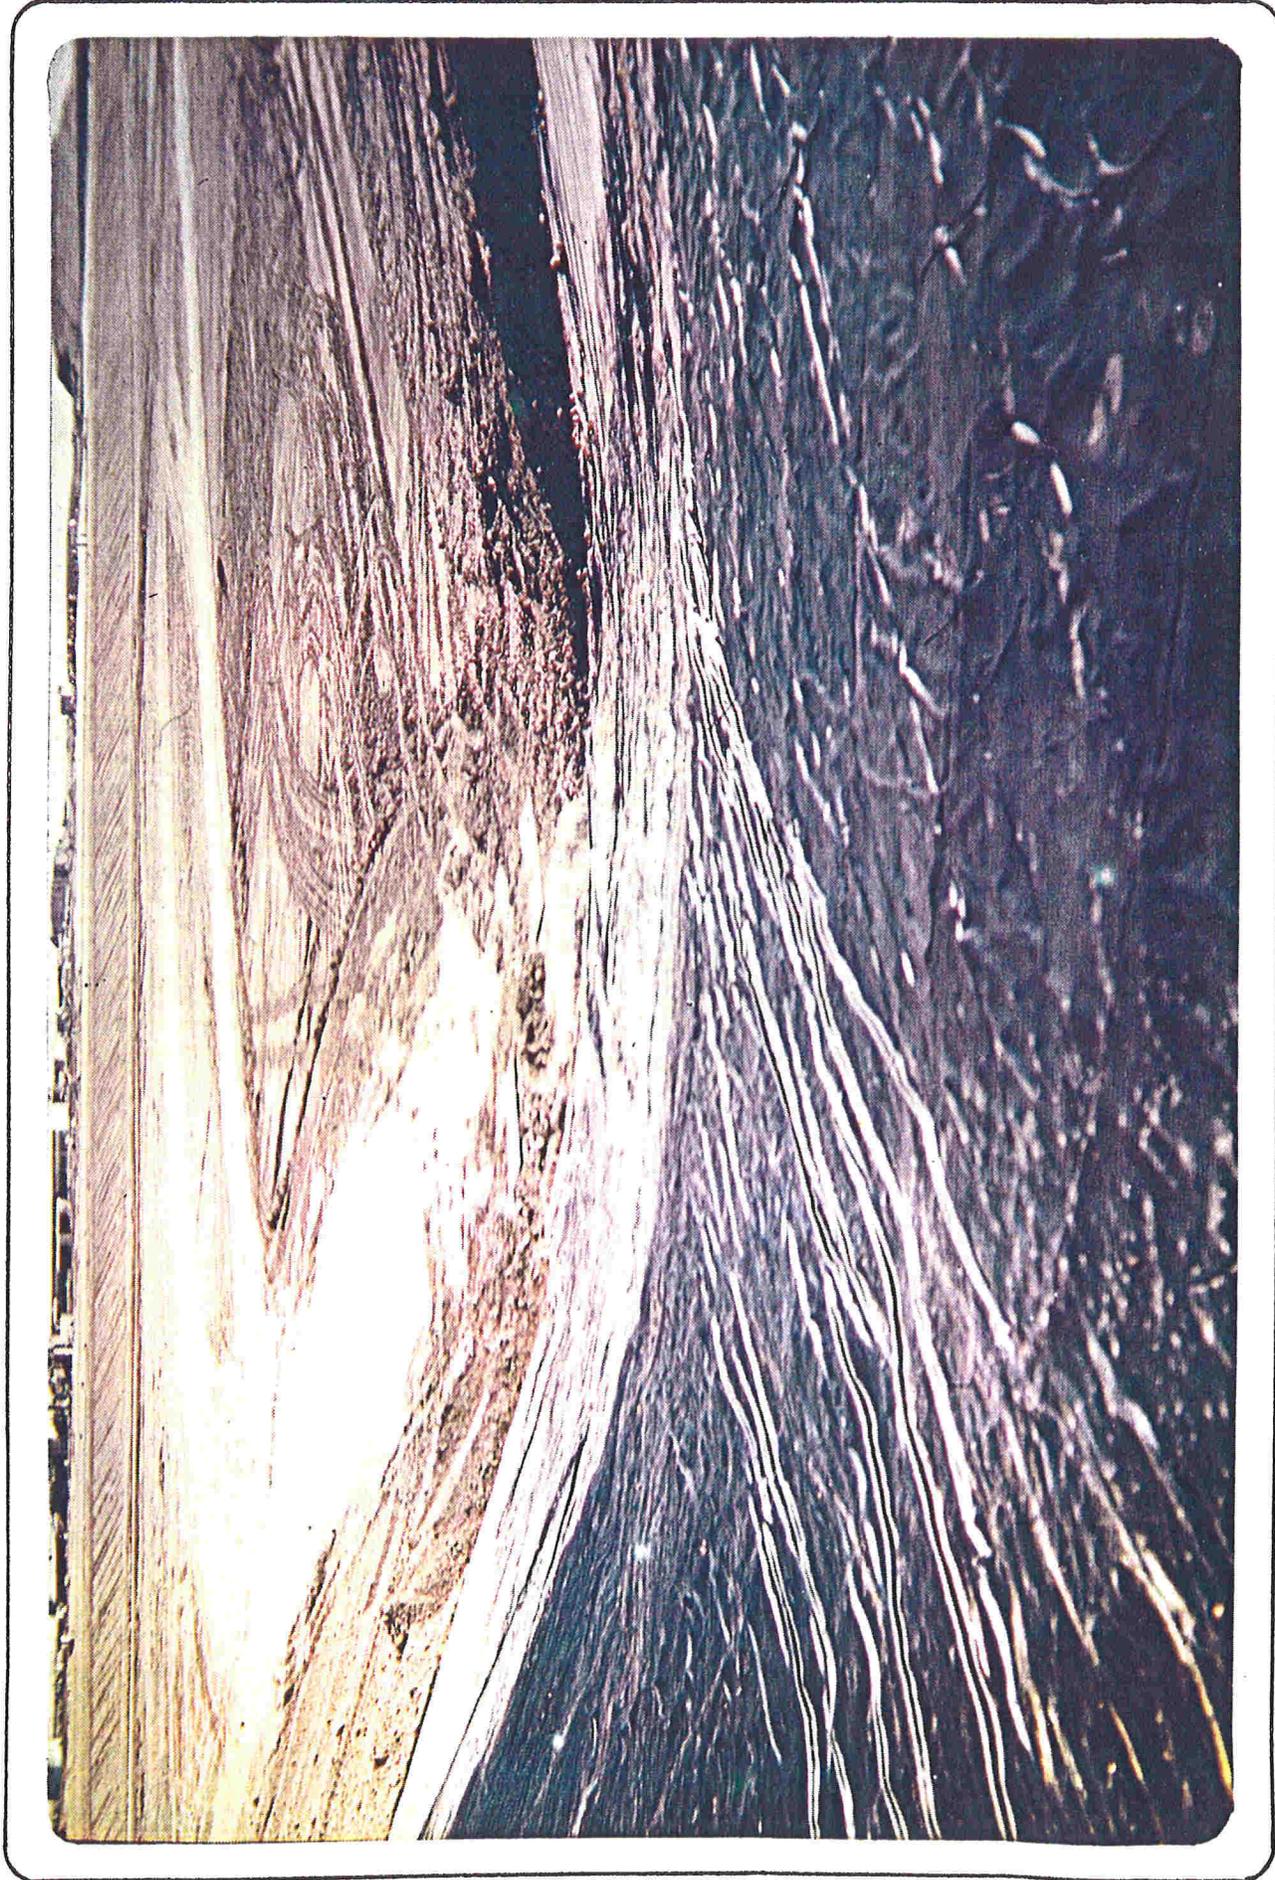
Cell 3 - Installation of PVC Liner Over Access Ramp
