# Development of Water Quality Standards for Willard Spur

## Update on Evaluation of Perry Willard Regional Wastewater Plant Impacts

January 30, 2014

Willard Spur Science Panel

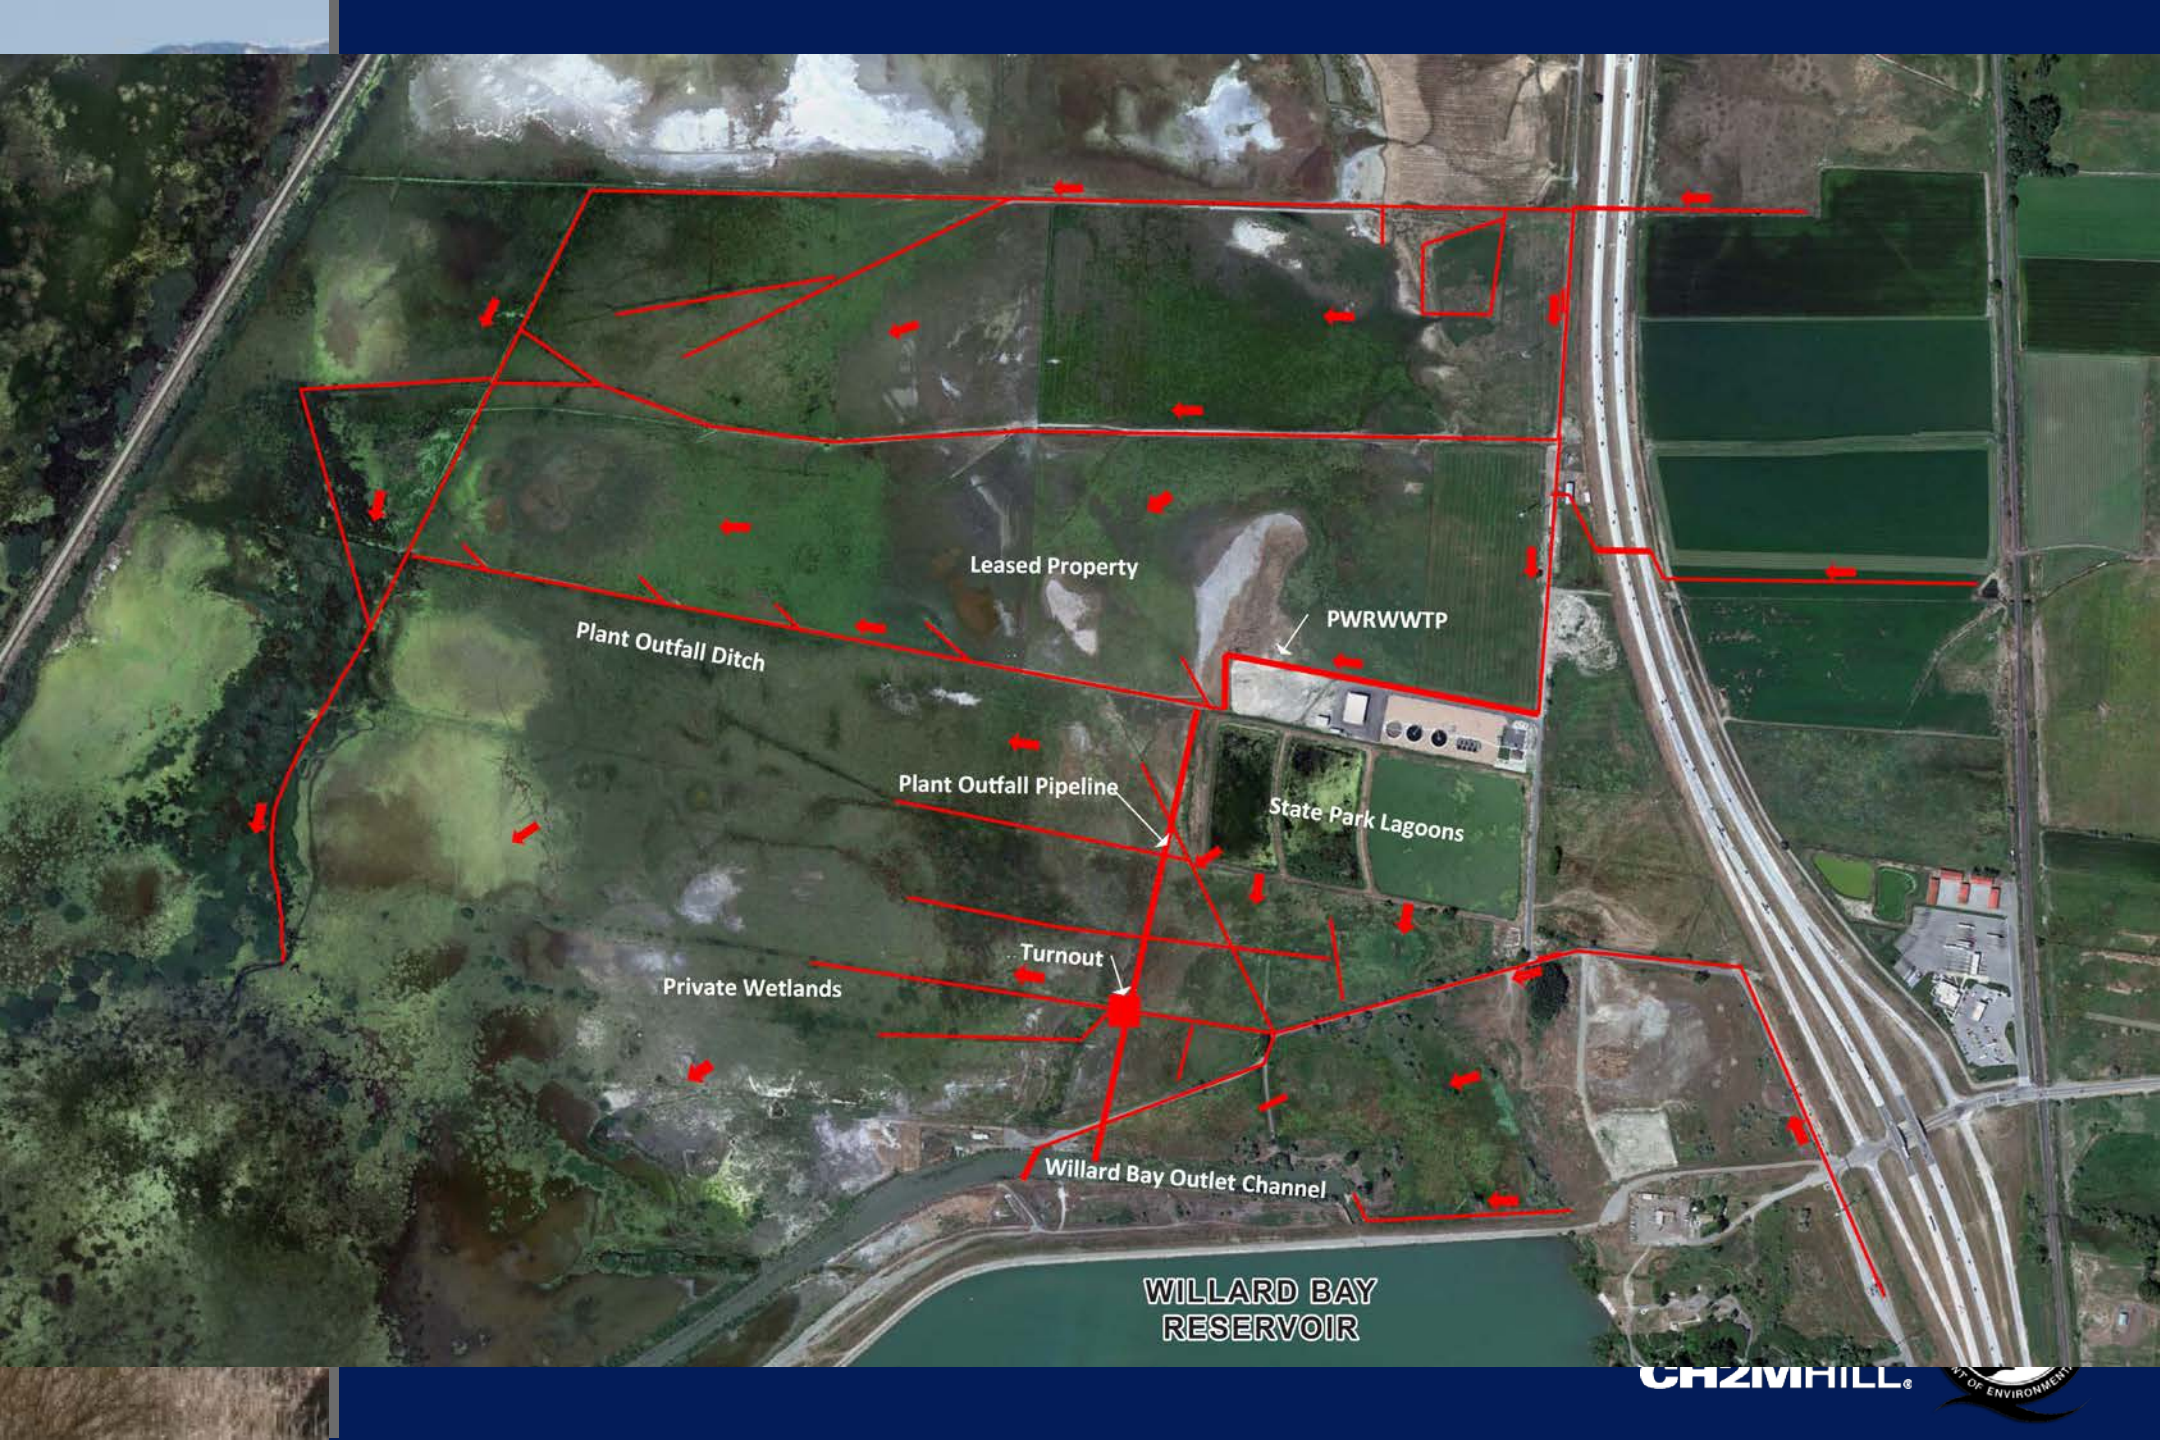
Plant Outfall Ditch

Plant Outfall Pipeline

Turnout

Willard Bay Outlet Channel

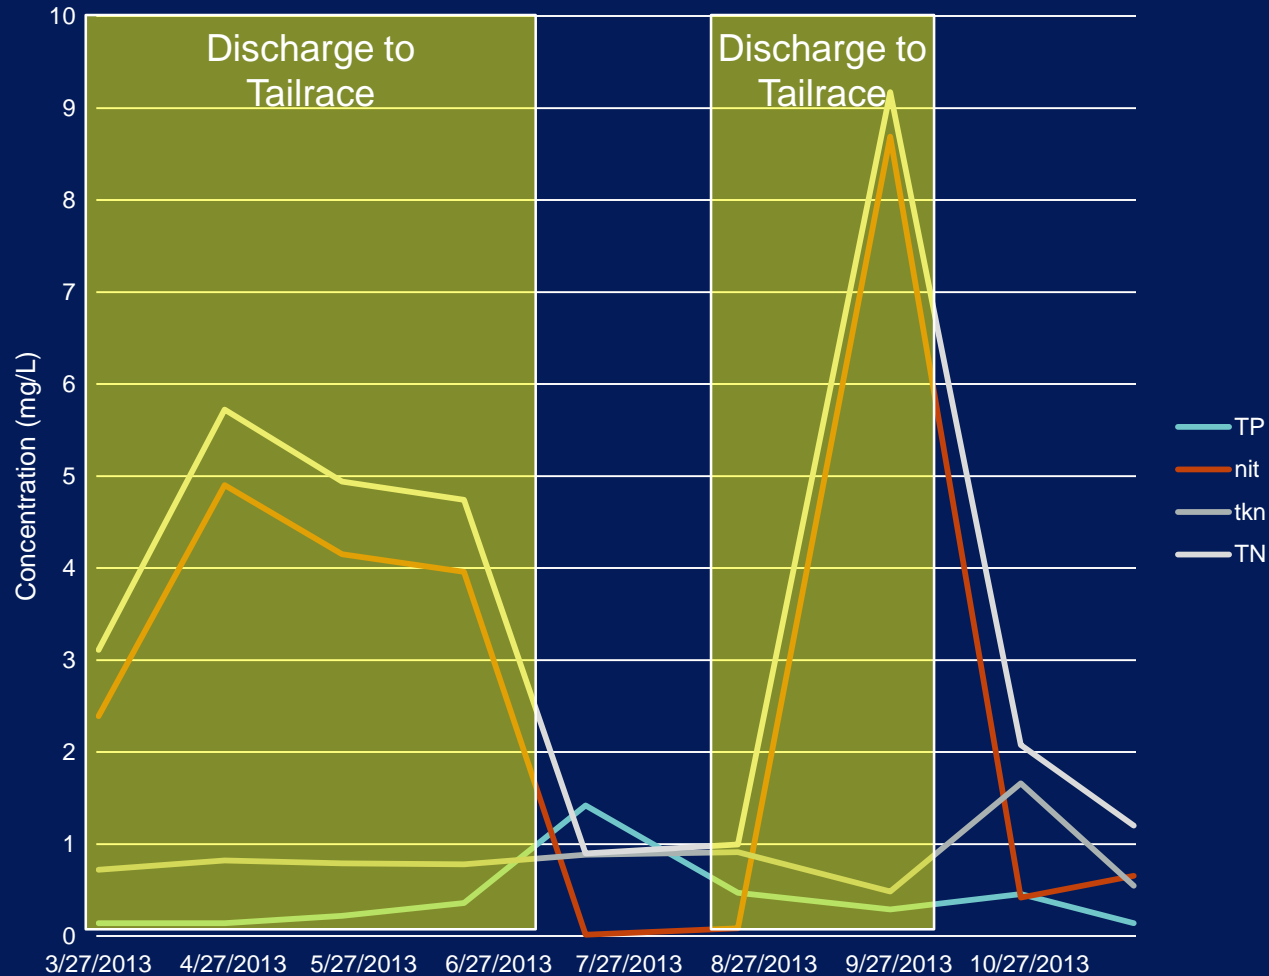
MZ-TAILRACE

# Tailrace Water Samples (2013)

- Can see signature from Plant in tailrace, drops quickly after flow is stopped
- Need to determine what true load to WS is from tailrace

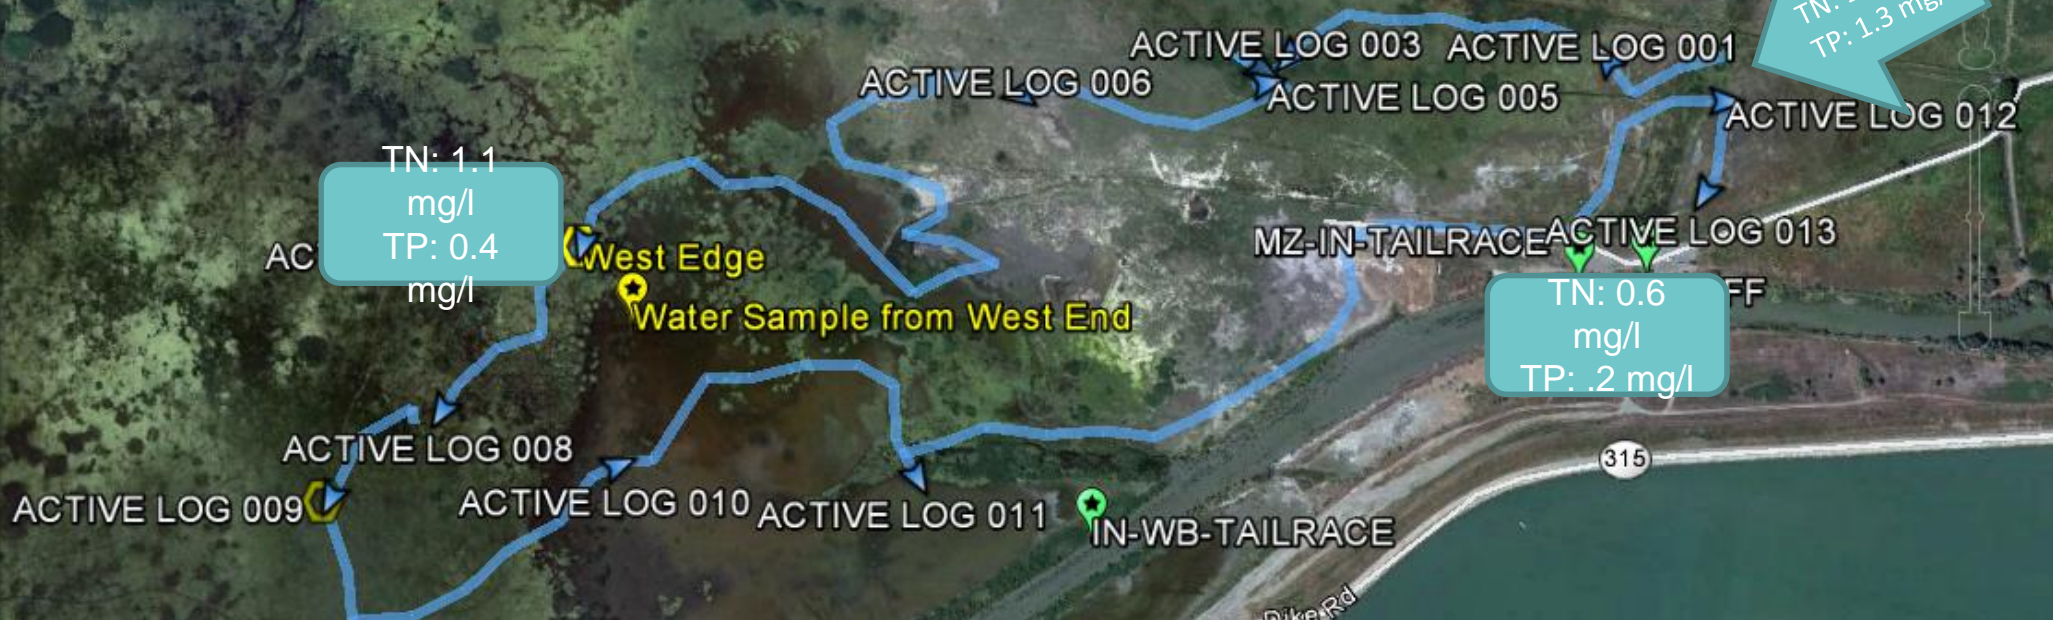
Effluent was discharged to pasture  
from July 10 – August 22

Wet area on Aug 19:  
50-60 acres

Substantial reduction in  
nutrients observed

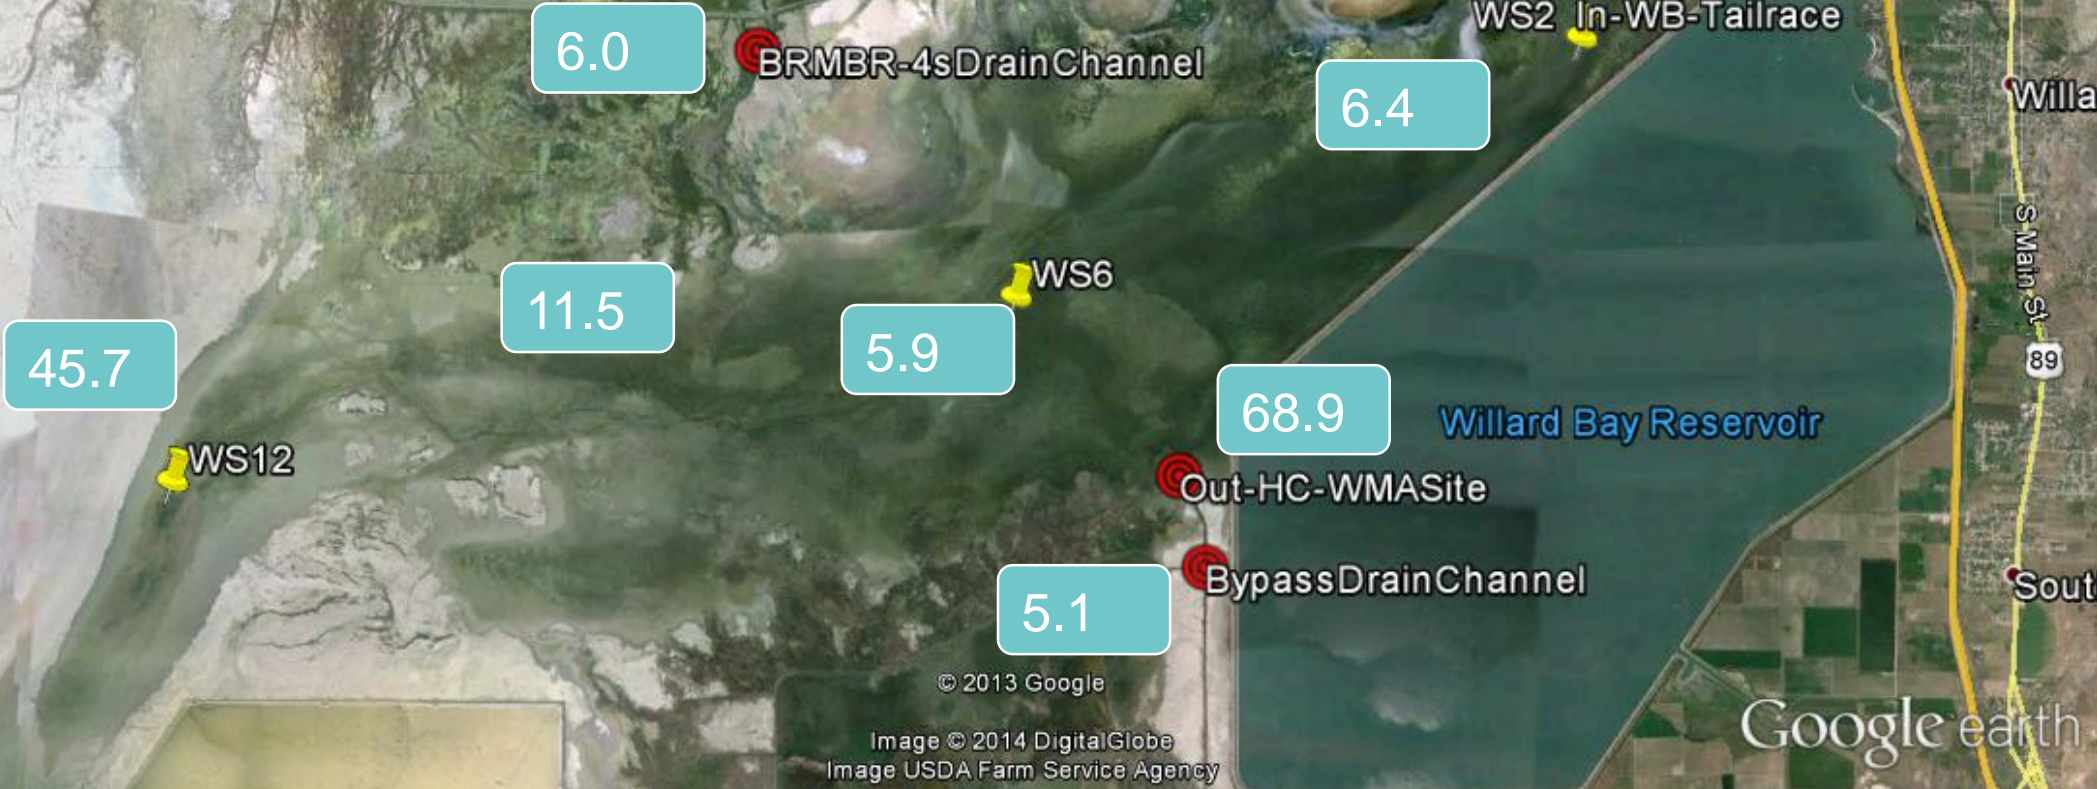
# Sediment Salinity (dS/m)

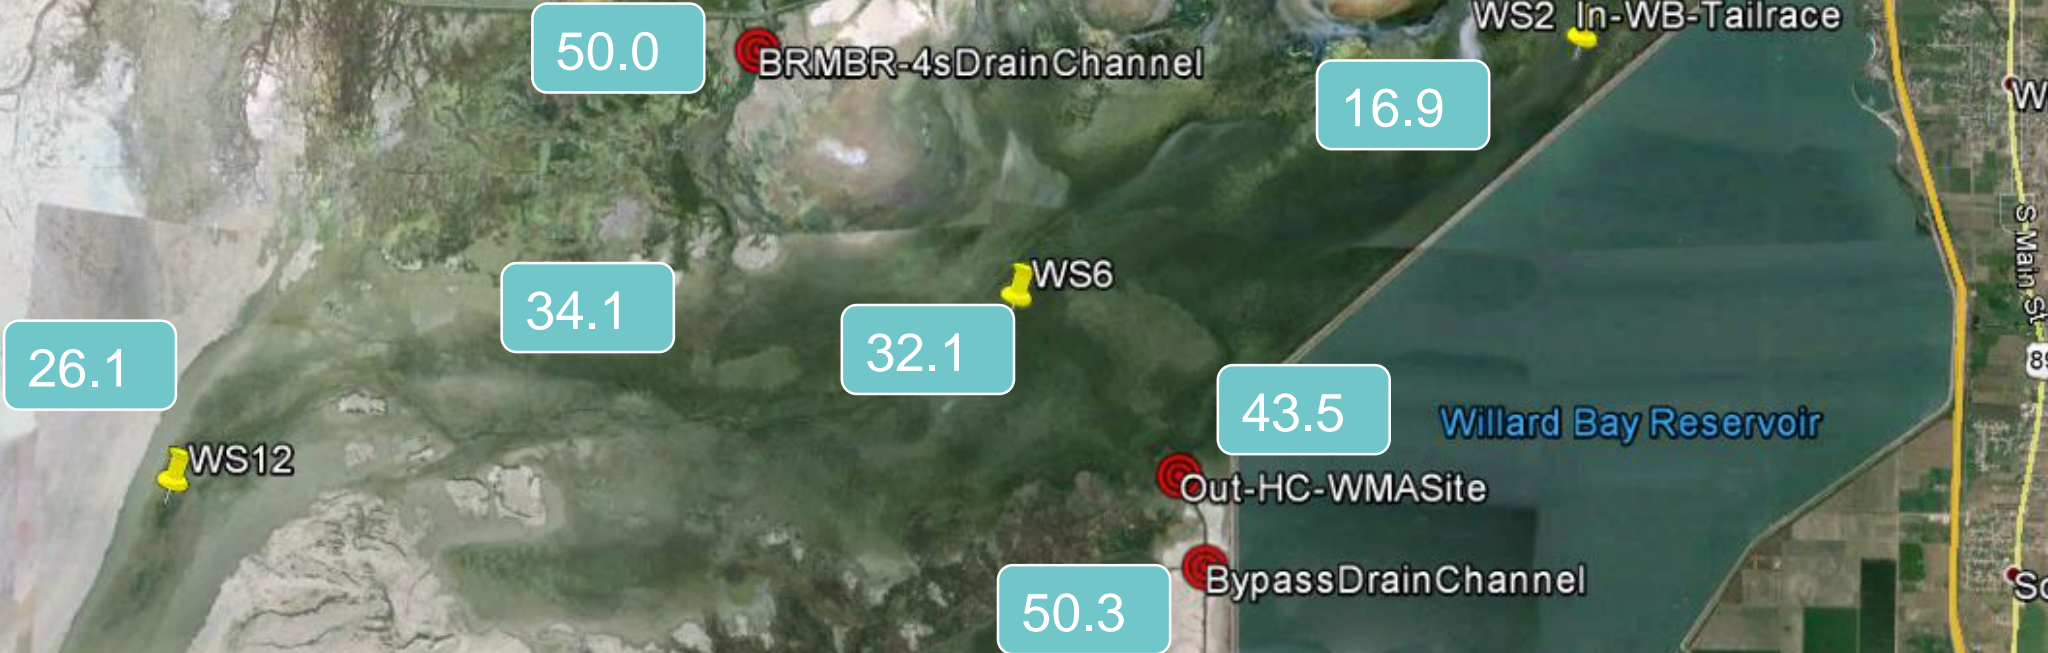
# Sediment P (mg/kg)

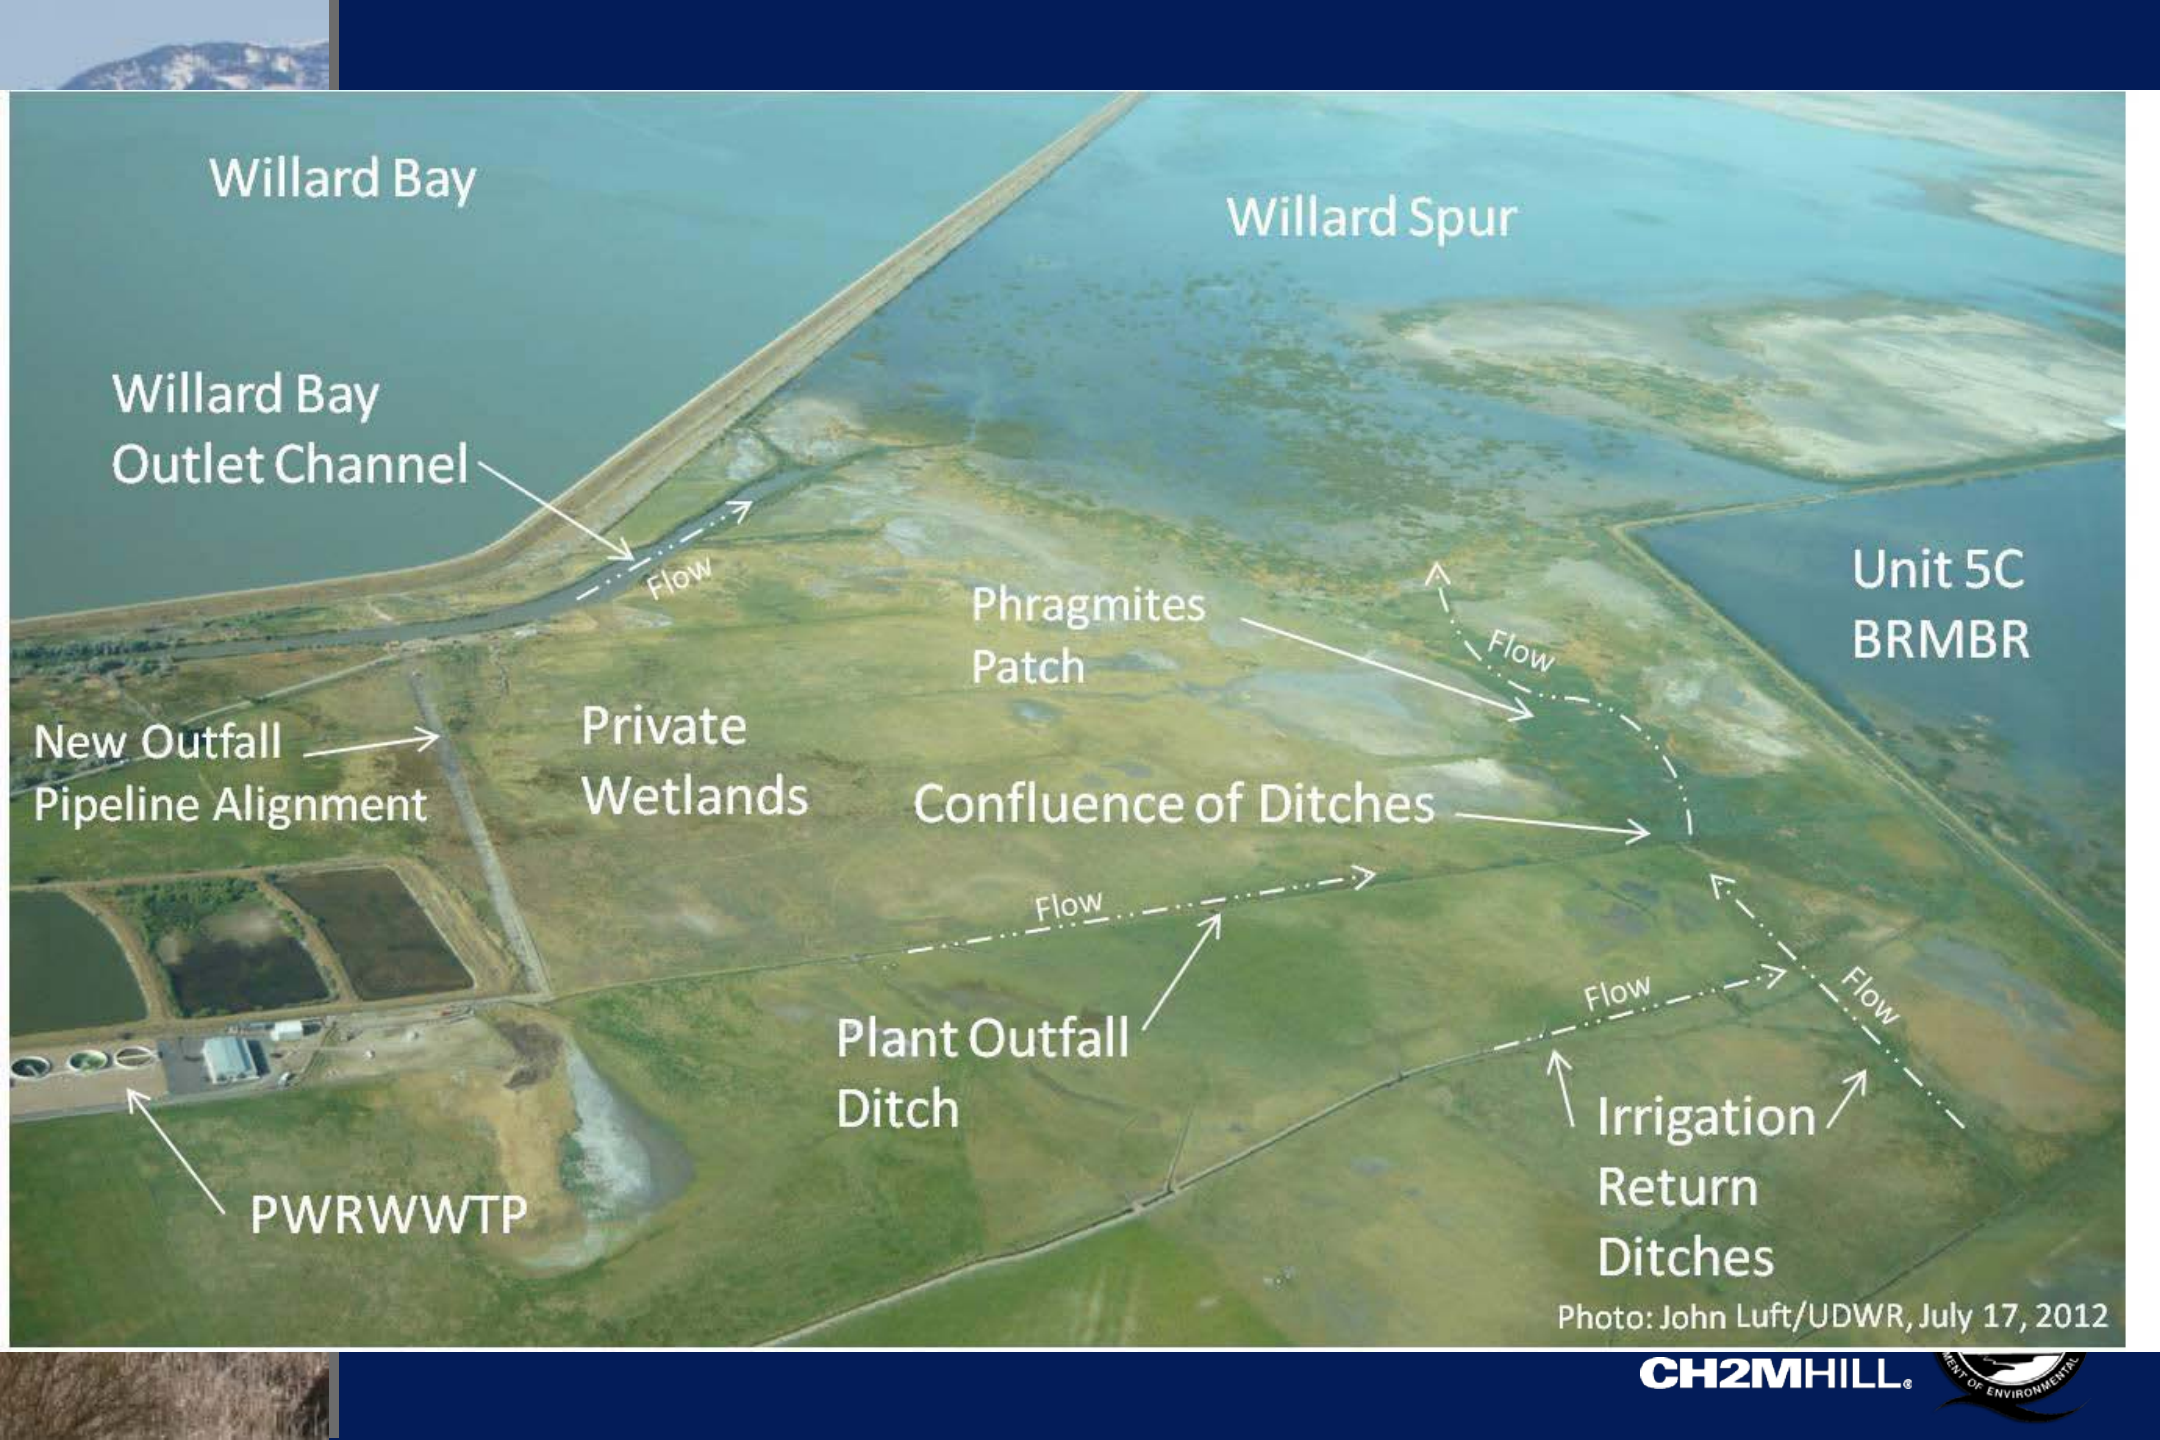
New Outfall  
Pipeline Alignment

Confluence of Ditches

Plant Outfall  
Ditch

Irrigation  
Return  
Ditches
