Re: Revision 3.0 to White Mesa Mill Reclamation Plan
License No. SUA-1358
Docket No. 40-8681

Reclamation Plan White Mesa Mill Blanding, Utah

Source Material License No. SUA-1358

Revision 3.0

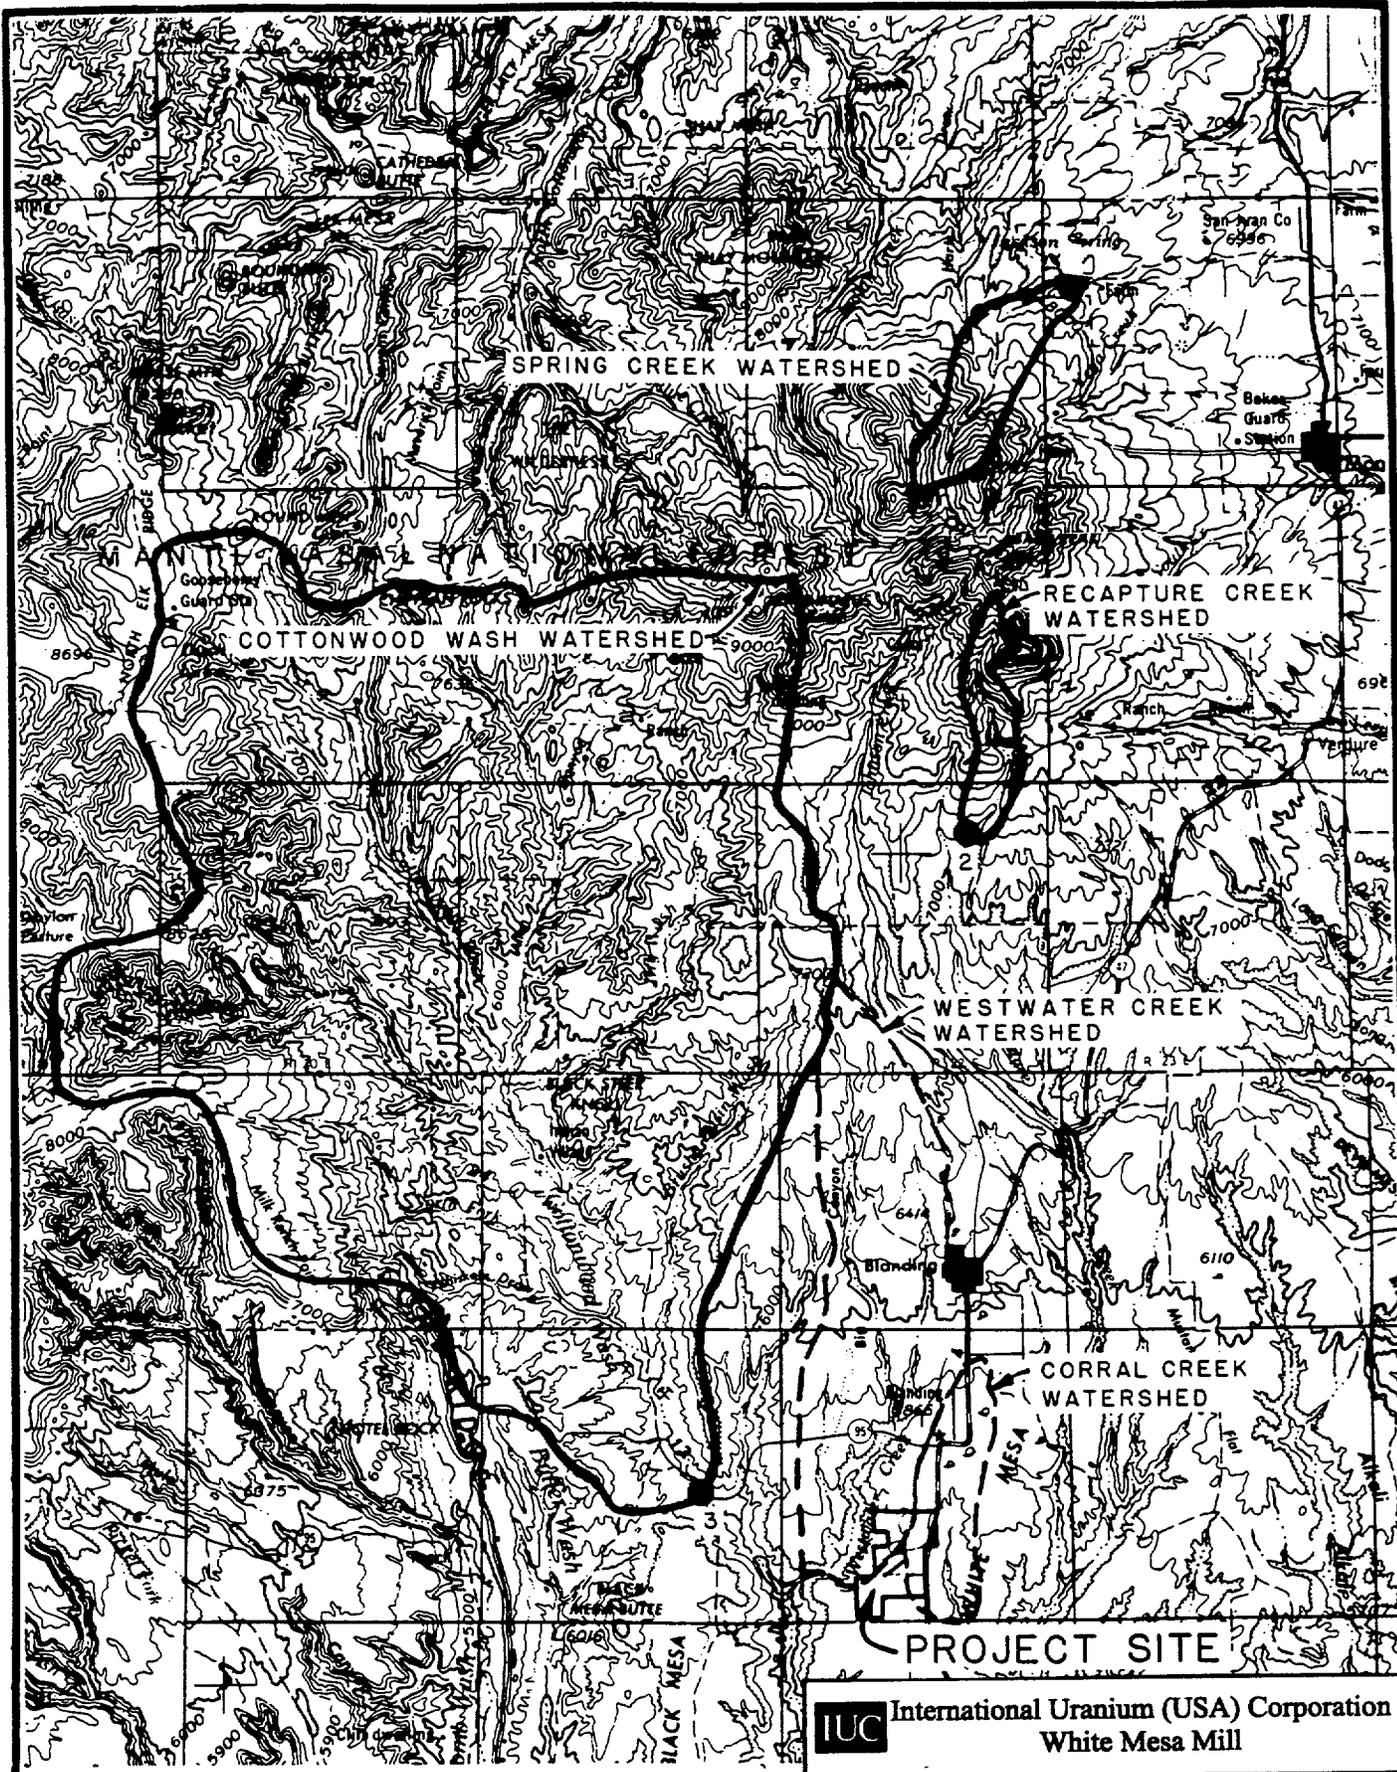
- 1 USGS GAUGE NO. 09376900
- 2 USGS GAUGE NO. 09378630
- 3 USGS GAUGE NO. 09378700

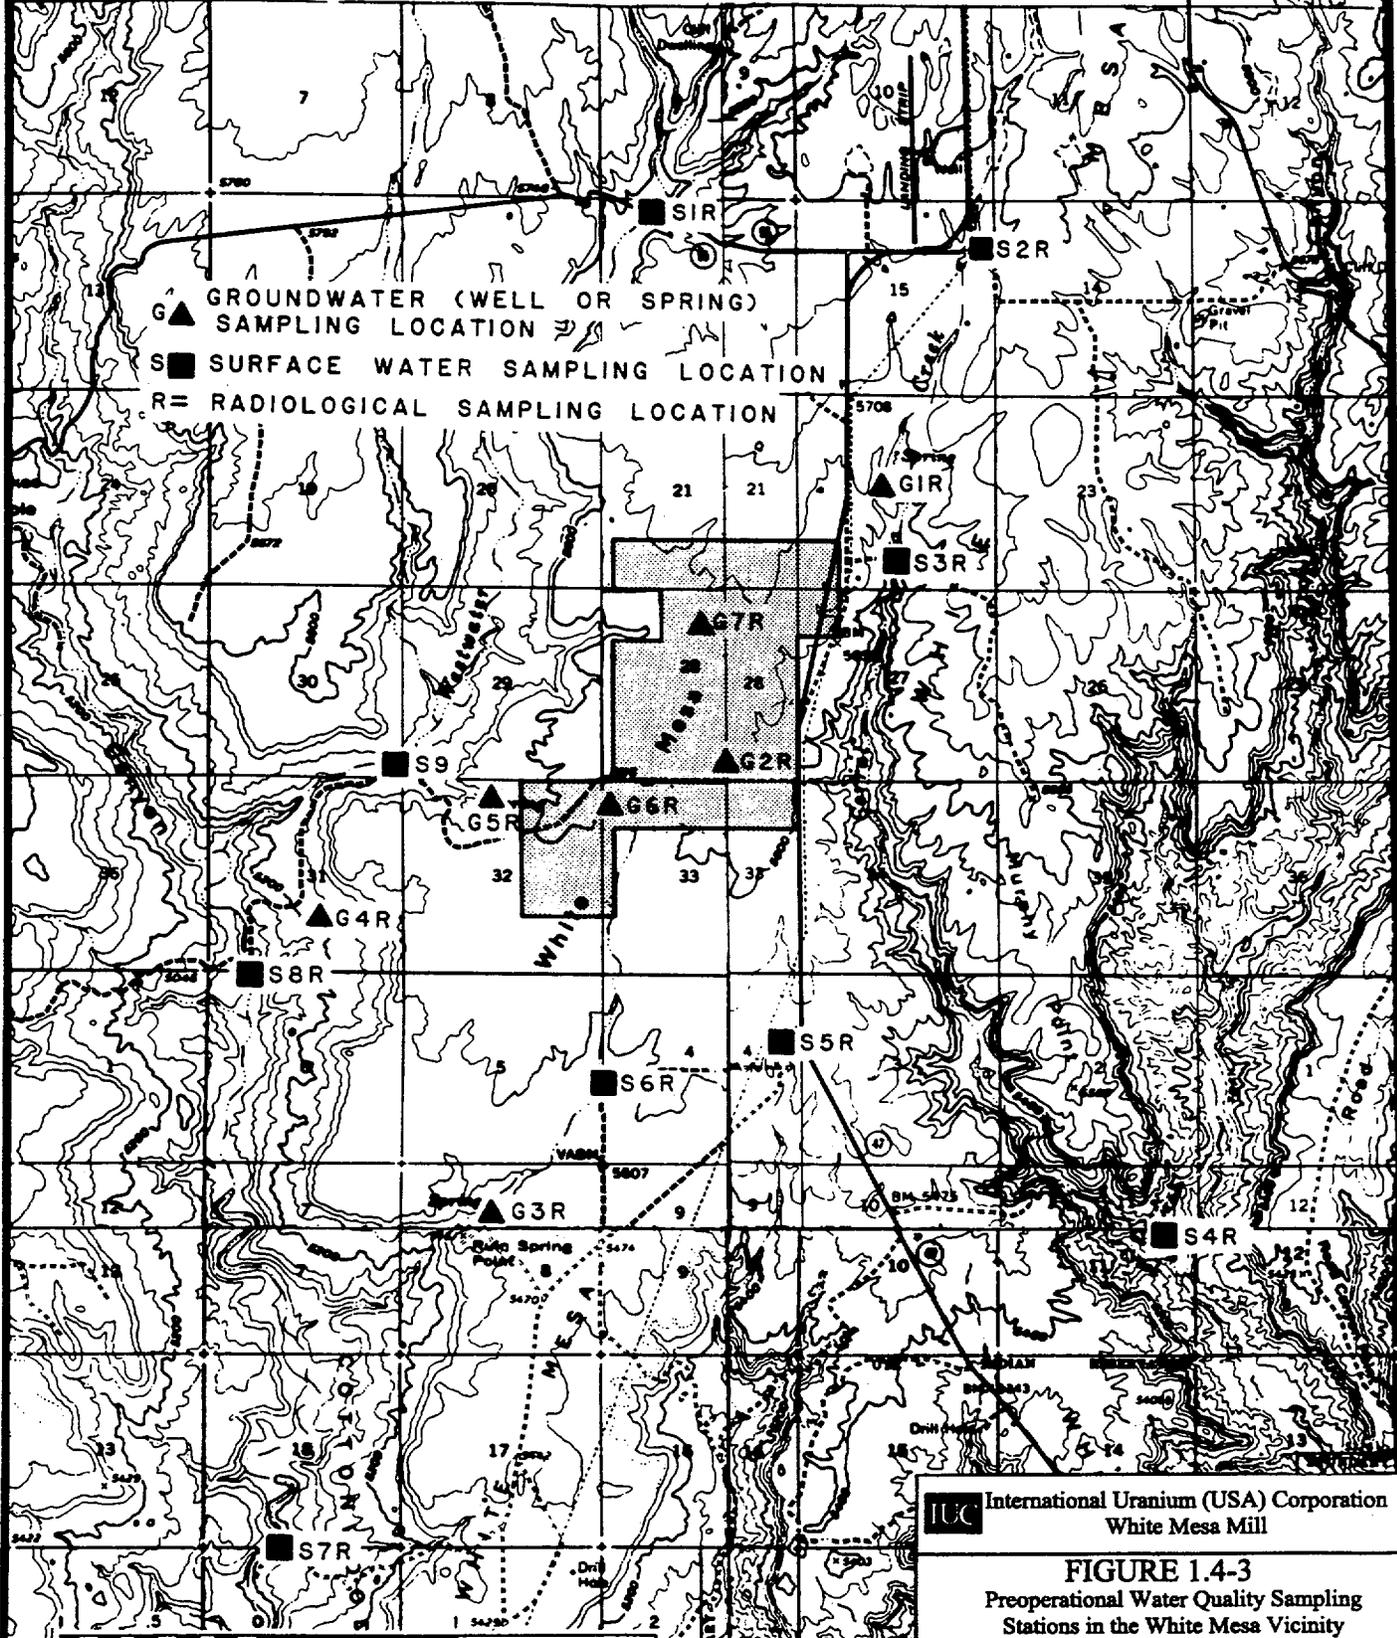
PREOPERATIONAL WATER QUALITY SAMPLING STATIONS IN PROJECT VICINITY

G ▲ GROUNDWATER (WELL OR SPRING) SAMPLING LOCATION
 S ■ SURFACE WATER SAMPLING LOCATION
 R = RADIOLOGICAL SAMPLING LOCATION

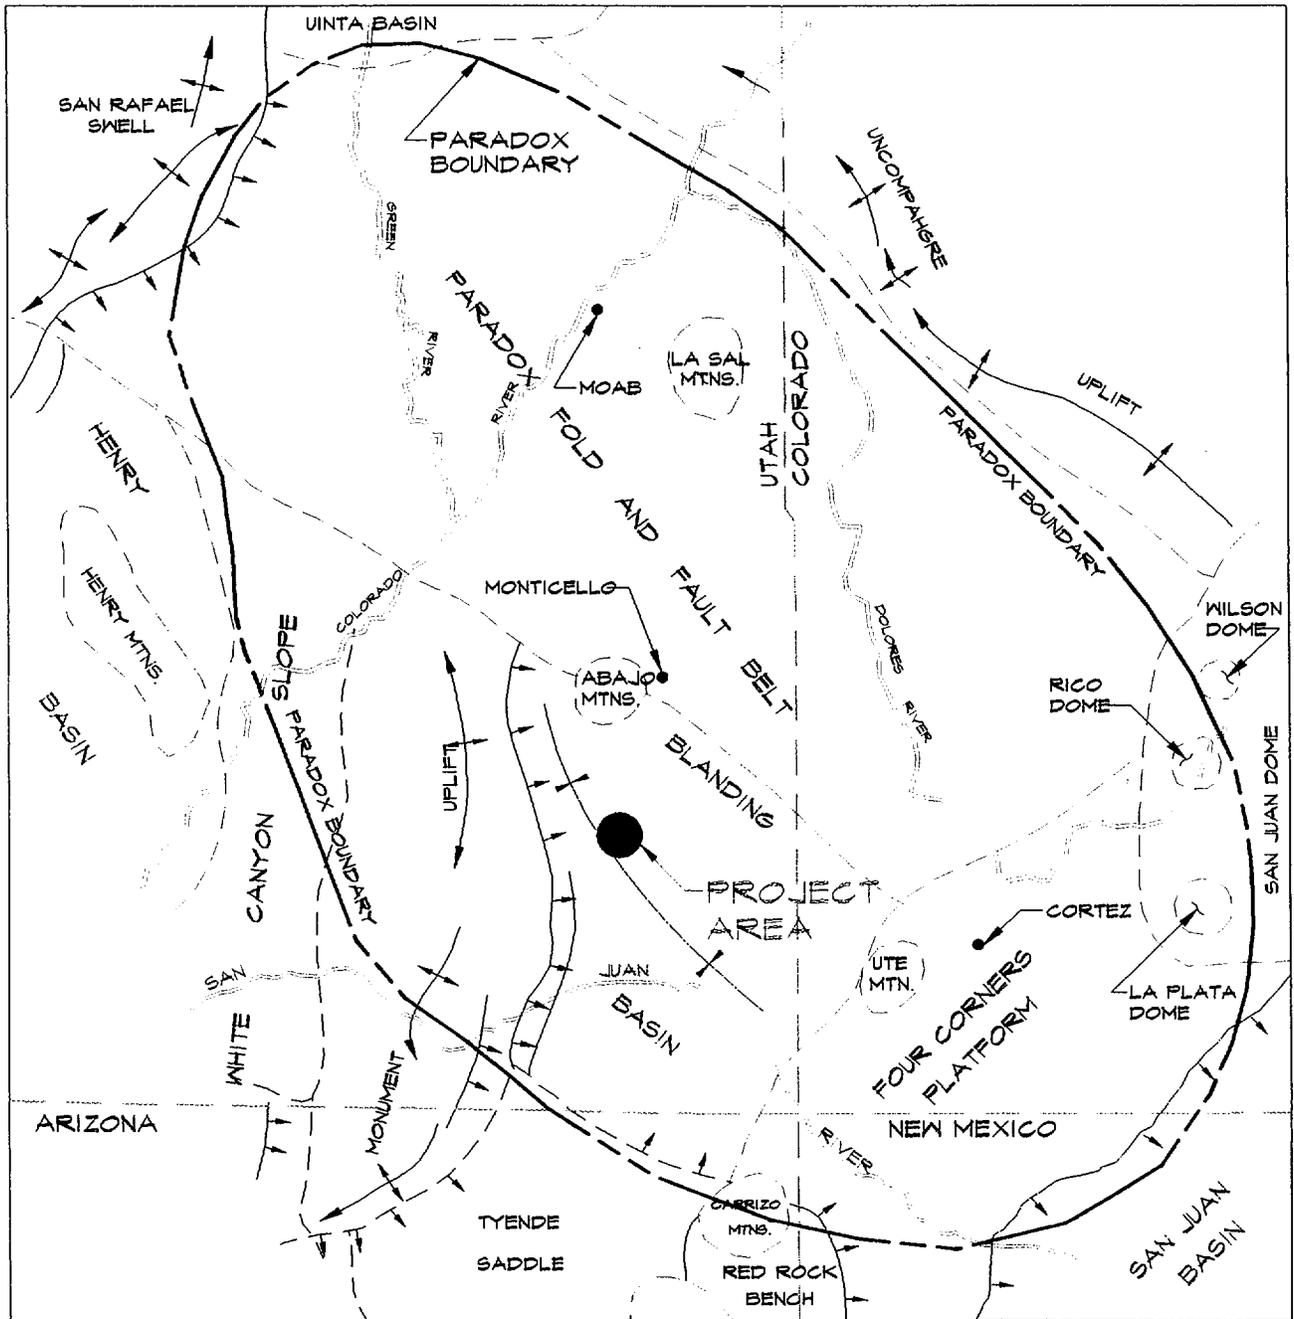
FIGURE 1.5.1
Colorado Plateau Geologic Map

- BOUNDARY OF TECTONIC DIVISION
- +— MONOCLINE SHOWING TRACE OF AXIS AND DIRECTION OF DIP
- +— ANTICLINE SHOWING TRACE OF AXIS AND DIRECTION OF PLUNGE
- +— SYNCLINE SHOWING TRACE OF AXIS AND DIRECTION OF PLUNGE

Recharge to aquifers in the region occurs by infiltration of precipitation into the aquifers along the flanks of the Abajo, Henry and La Sal Mountains and along the flanks of folds, such as Comb Ridge Monocline and the San Rafael Swell, where the permeable formations are exposed at the surface (Figure 1.5-1, Hydrogeologic Evaluation Figure 1.1).

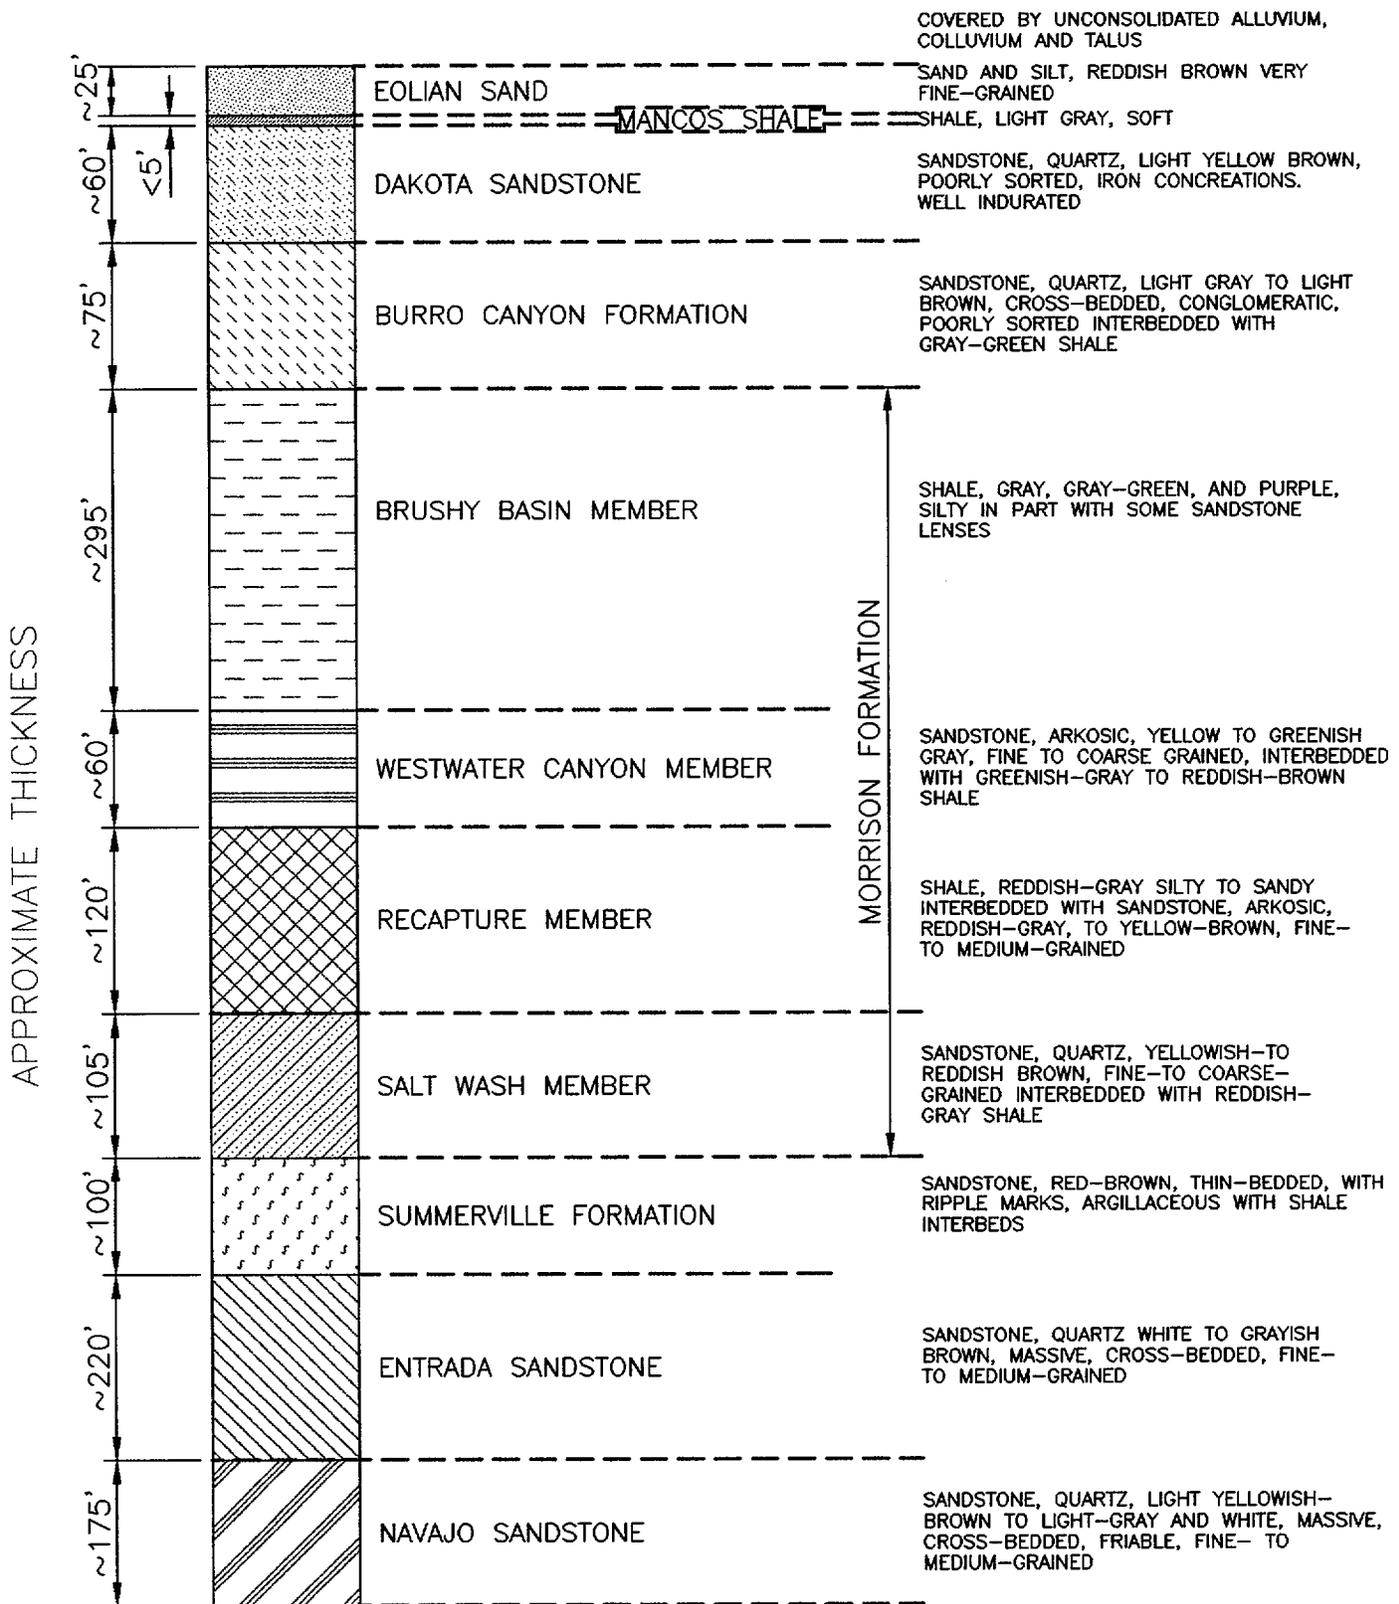
FIGURE 1.5-2

Generalized Stratigraphy of White Mesa

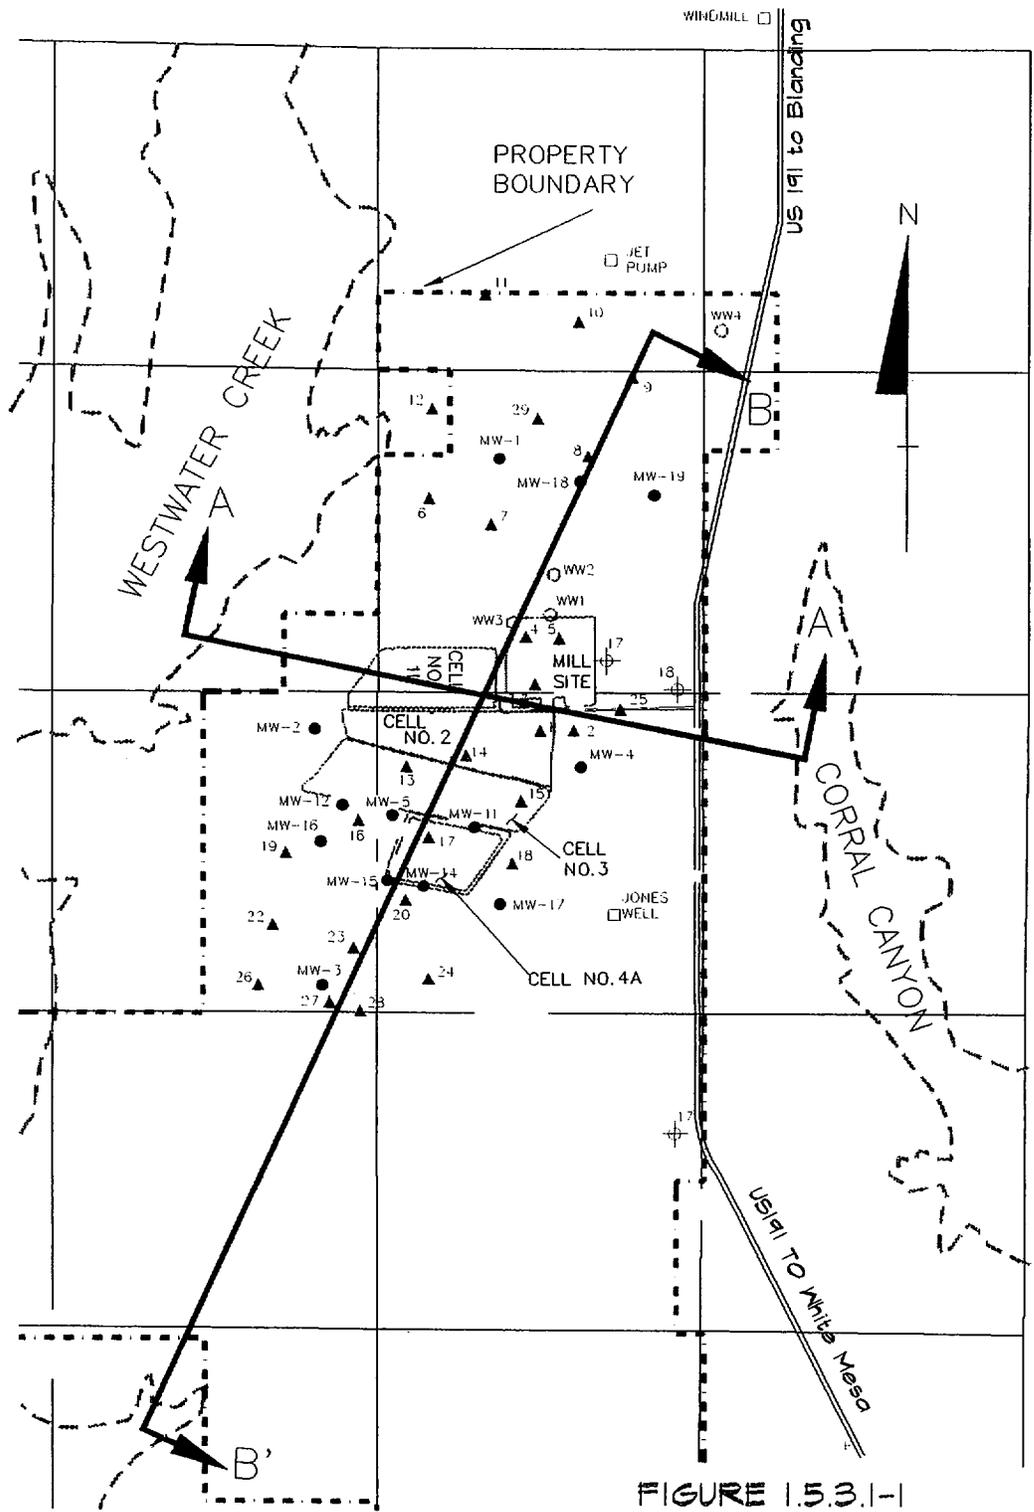
FIGURE I.5.3.1-1

White Mesa Mill
 Site Plan Map showing
 Monitor Wells and Borings

The thickness of the Brushy Basin Member in this region reportedly varies from 200-450 feet (Dames & Moore, 1978). This stratum was penetrated by six water supply wells [see Figure 1.5.3.1-1 (Hydrogeologic Evaluation Figure 2.1)] and Appendix A of the Hydrogeologic Evaluation) and its thickness was estimated at 275 feet. Borings which terminate in the Brushy Basin Member encounter moderately plastic dark green to dark reddish-brown mudstones. Plastic bentonitic mudstone is not prone to develop fracturing. Hence, competency of this strata, as an aquitard, is very likely.

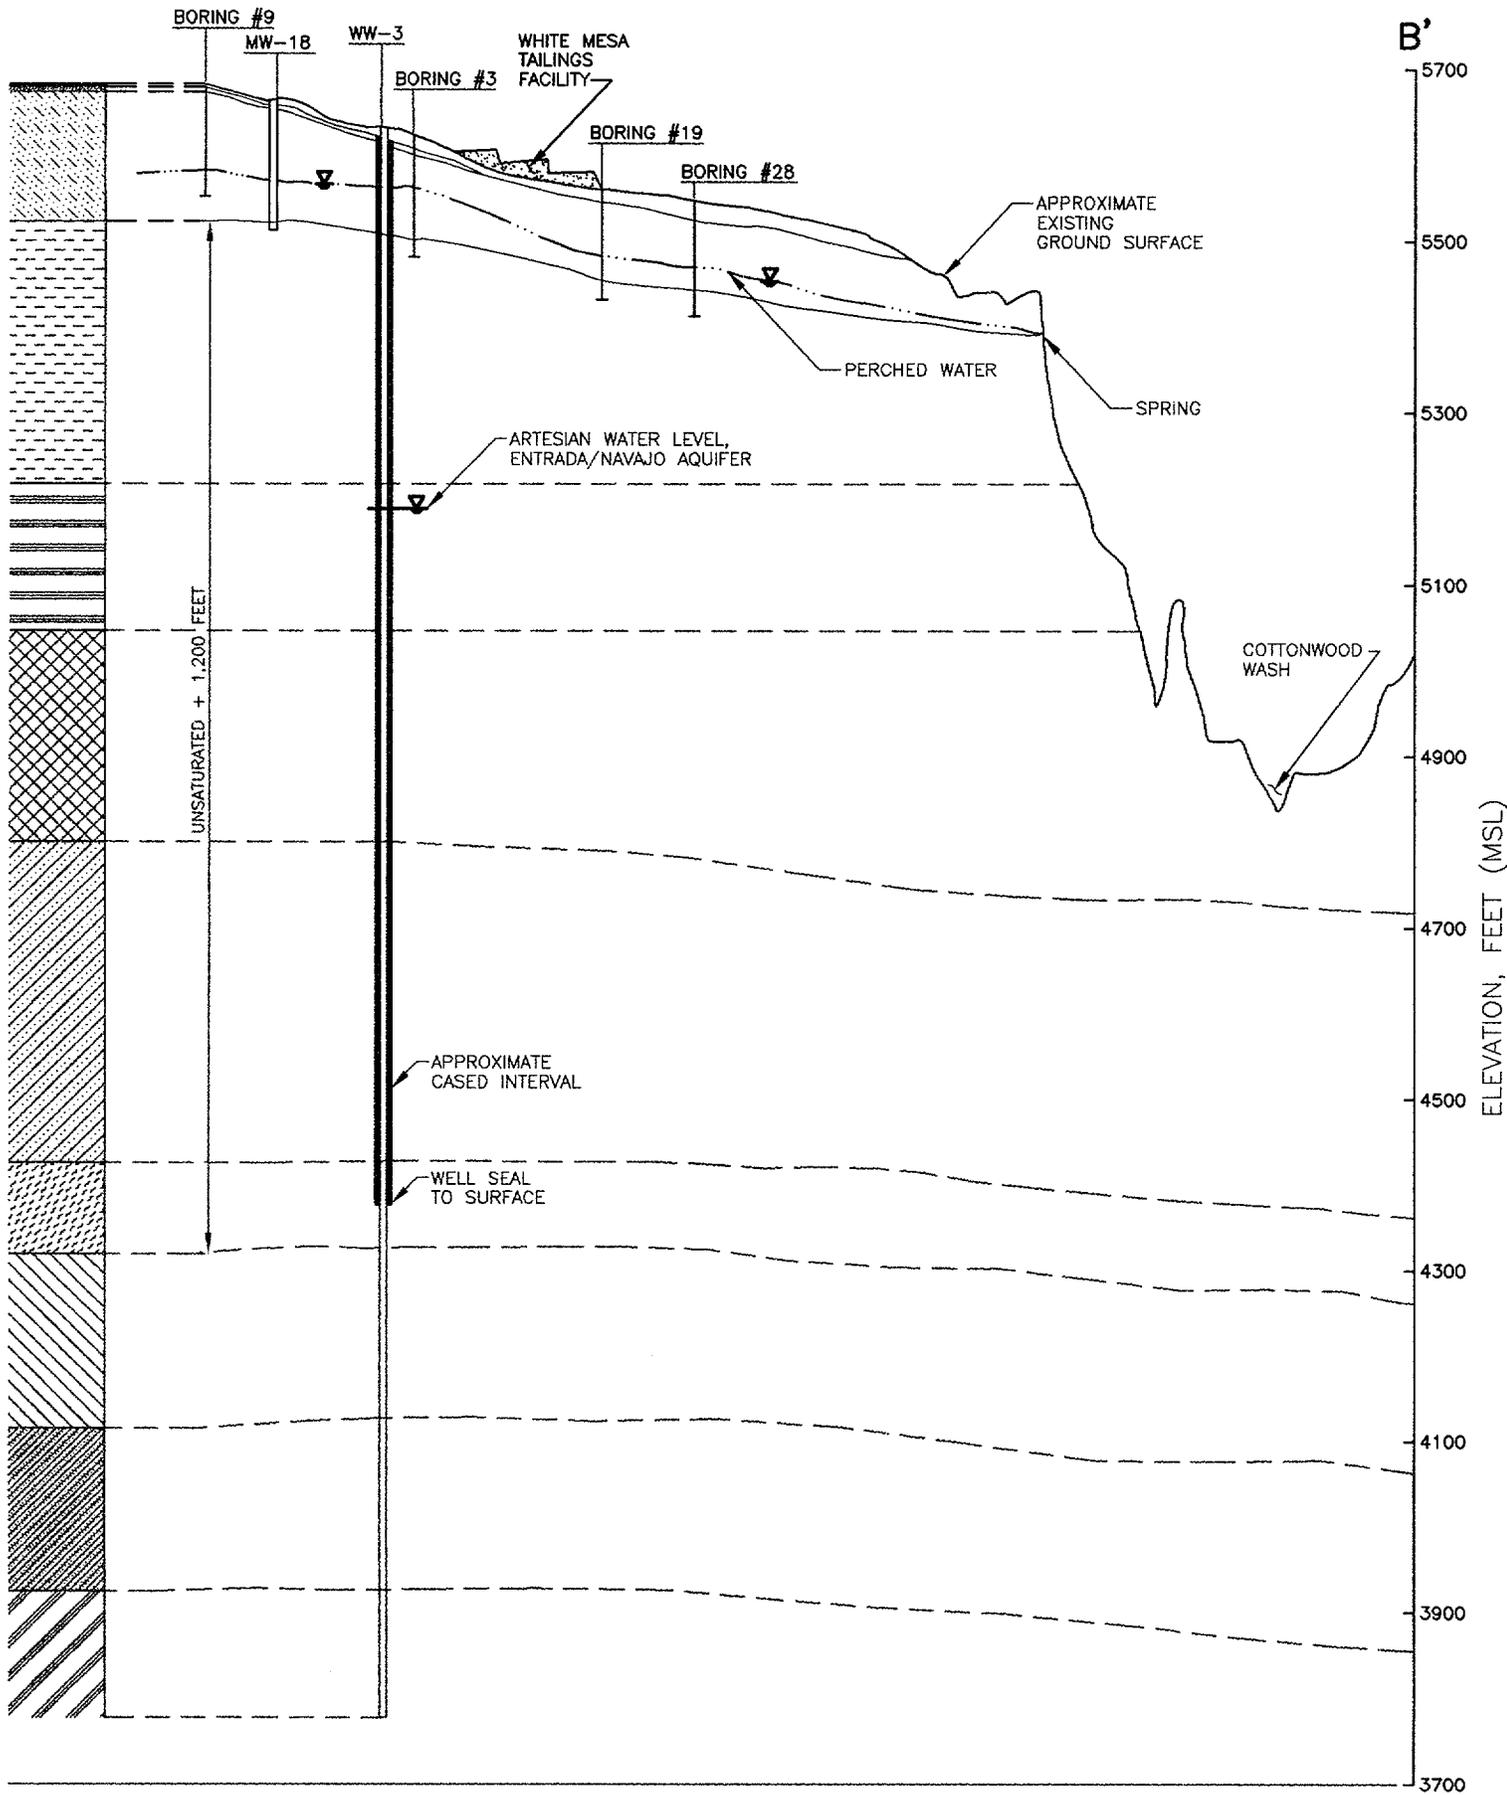
FIGURE 1.5.3.1-3
WHITE MESA MILL

Section B-B'

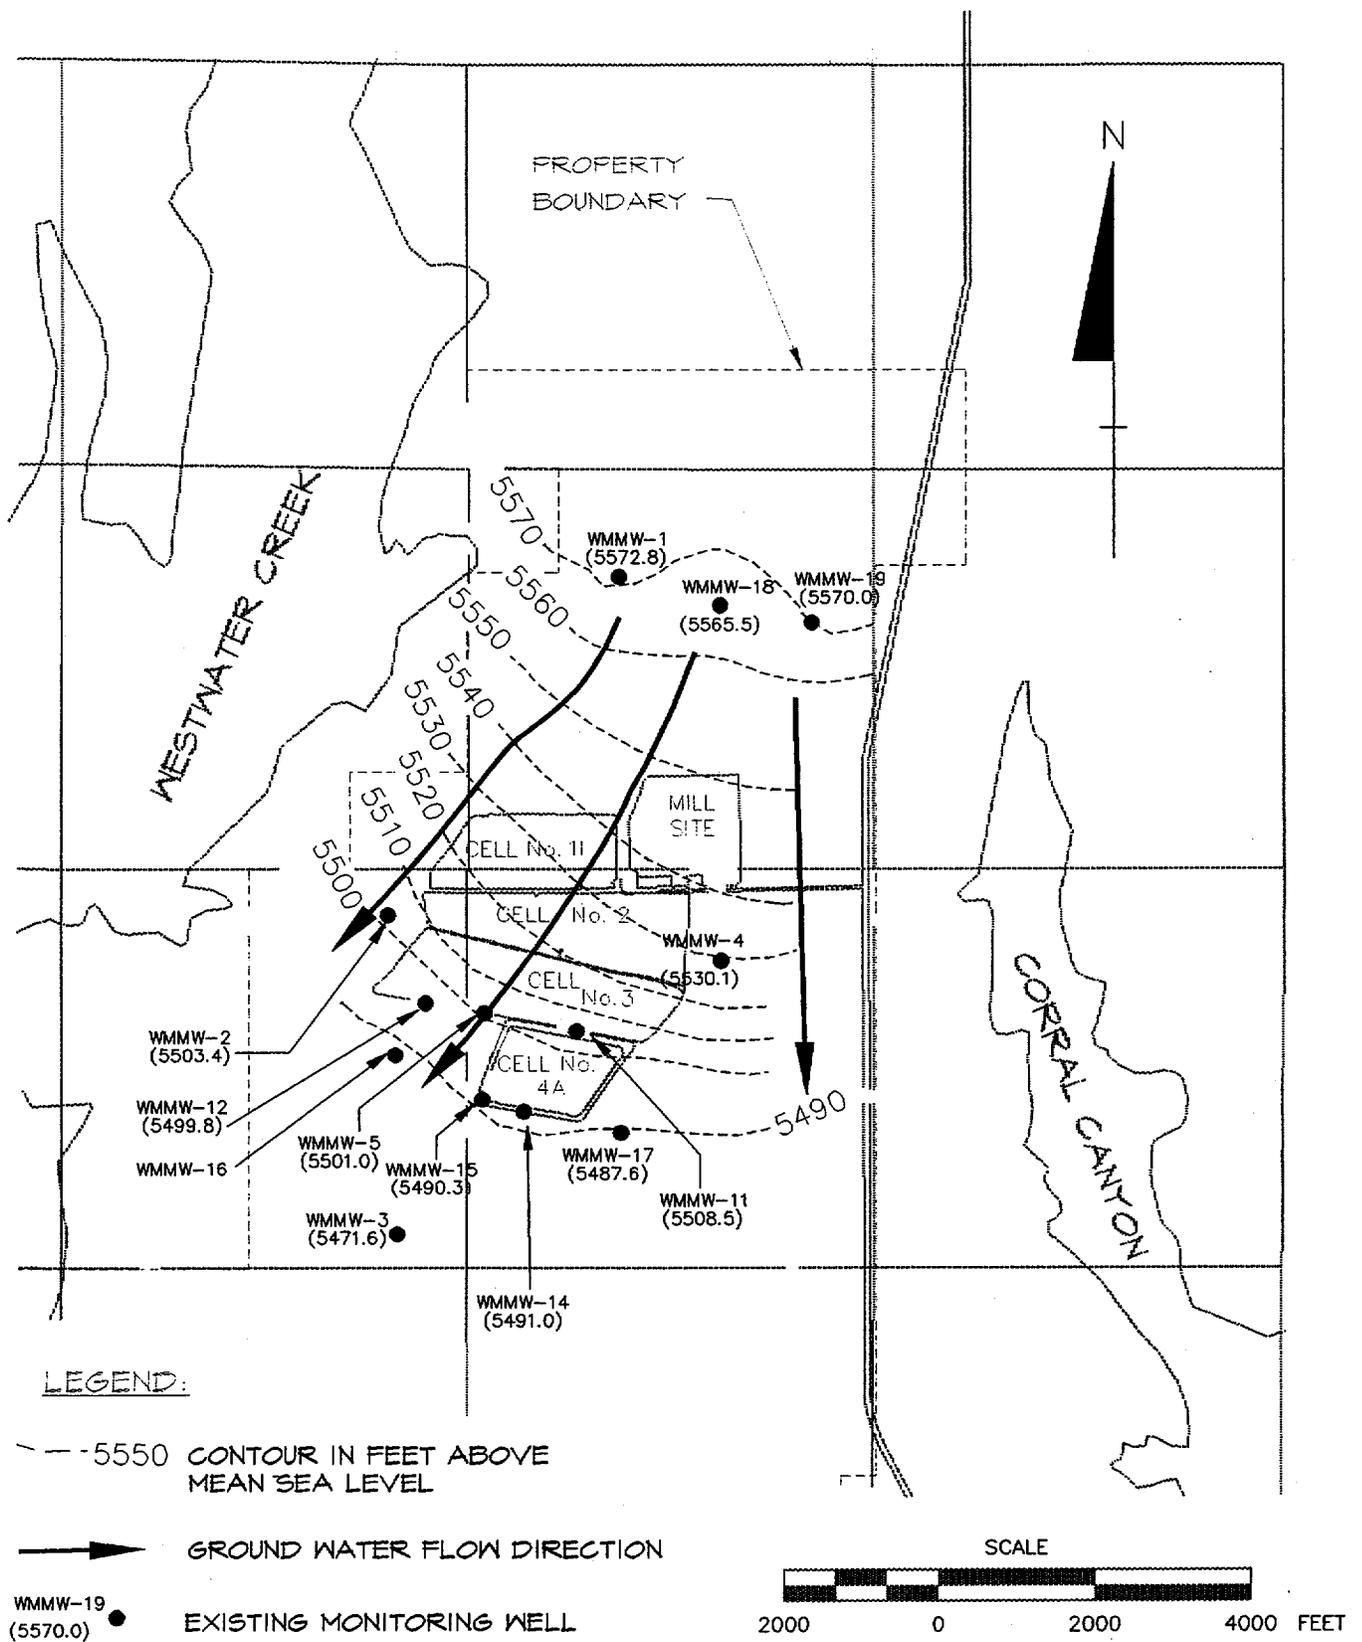
FIGURE I.5.5-1 : Perched Ground Water Levels

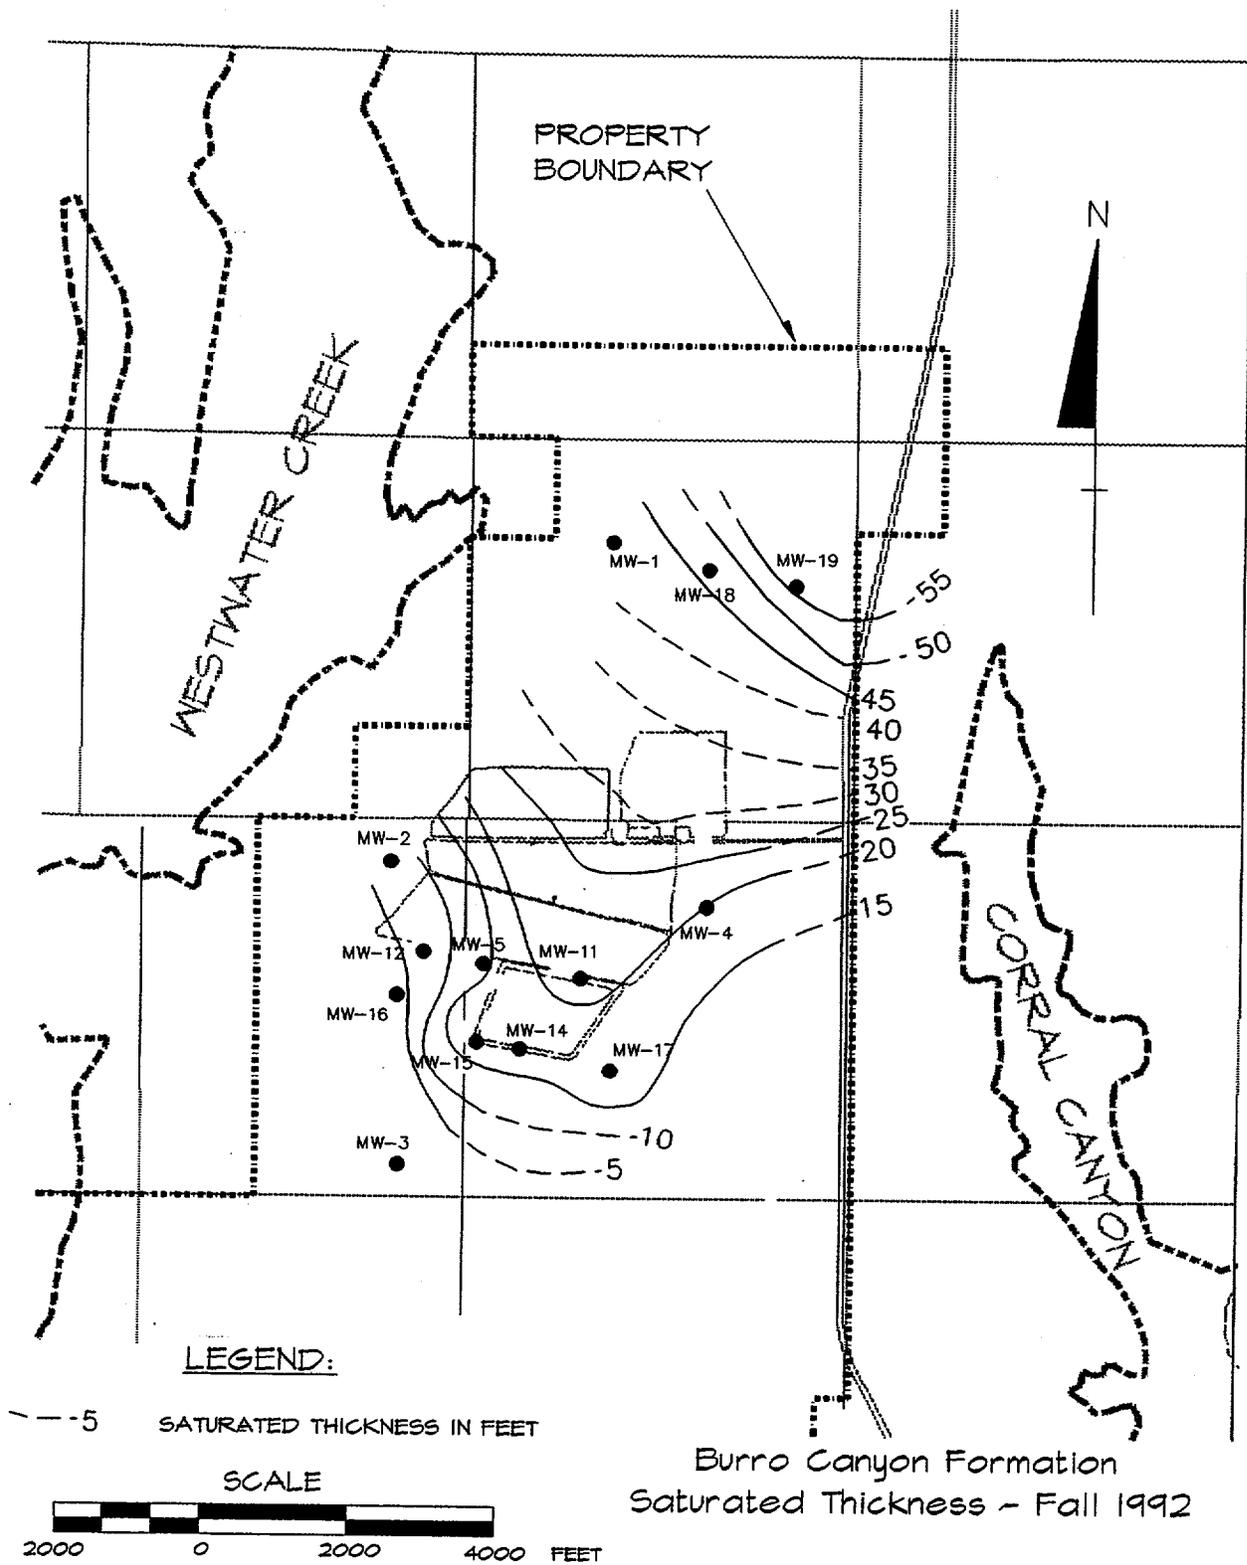
FIGURE I.5.5-2: Saturated Thickness of Perched Water

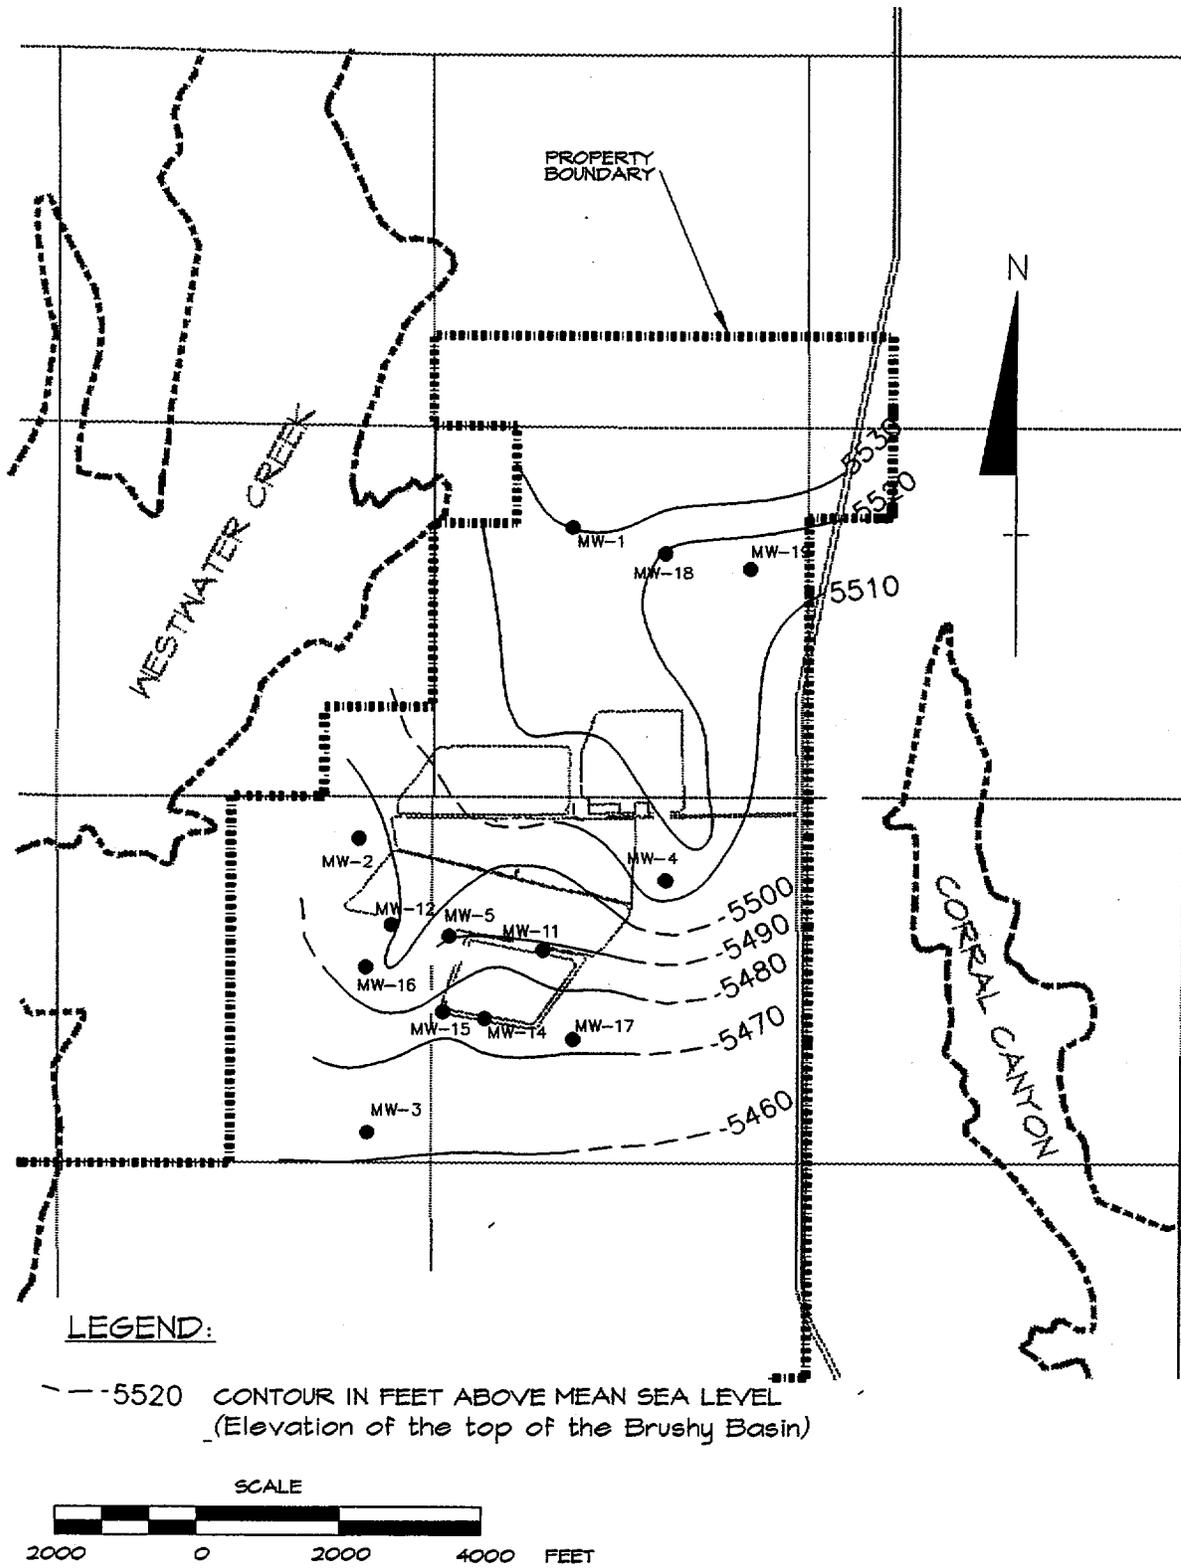
FIGURE I.5.5-3: Topography of the Brushy Basin Formation

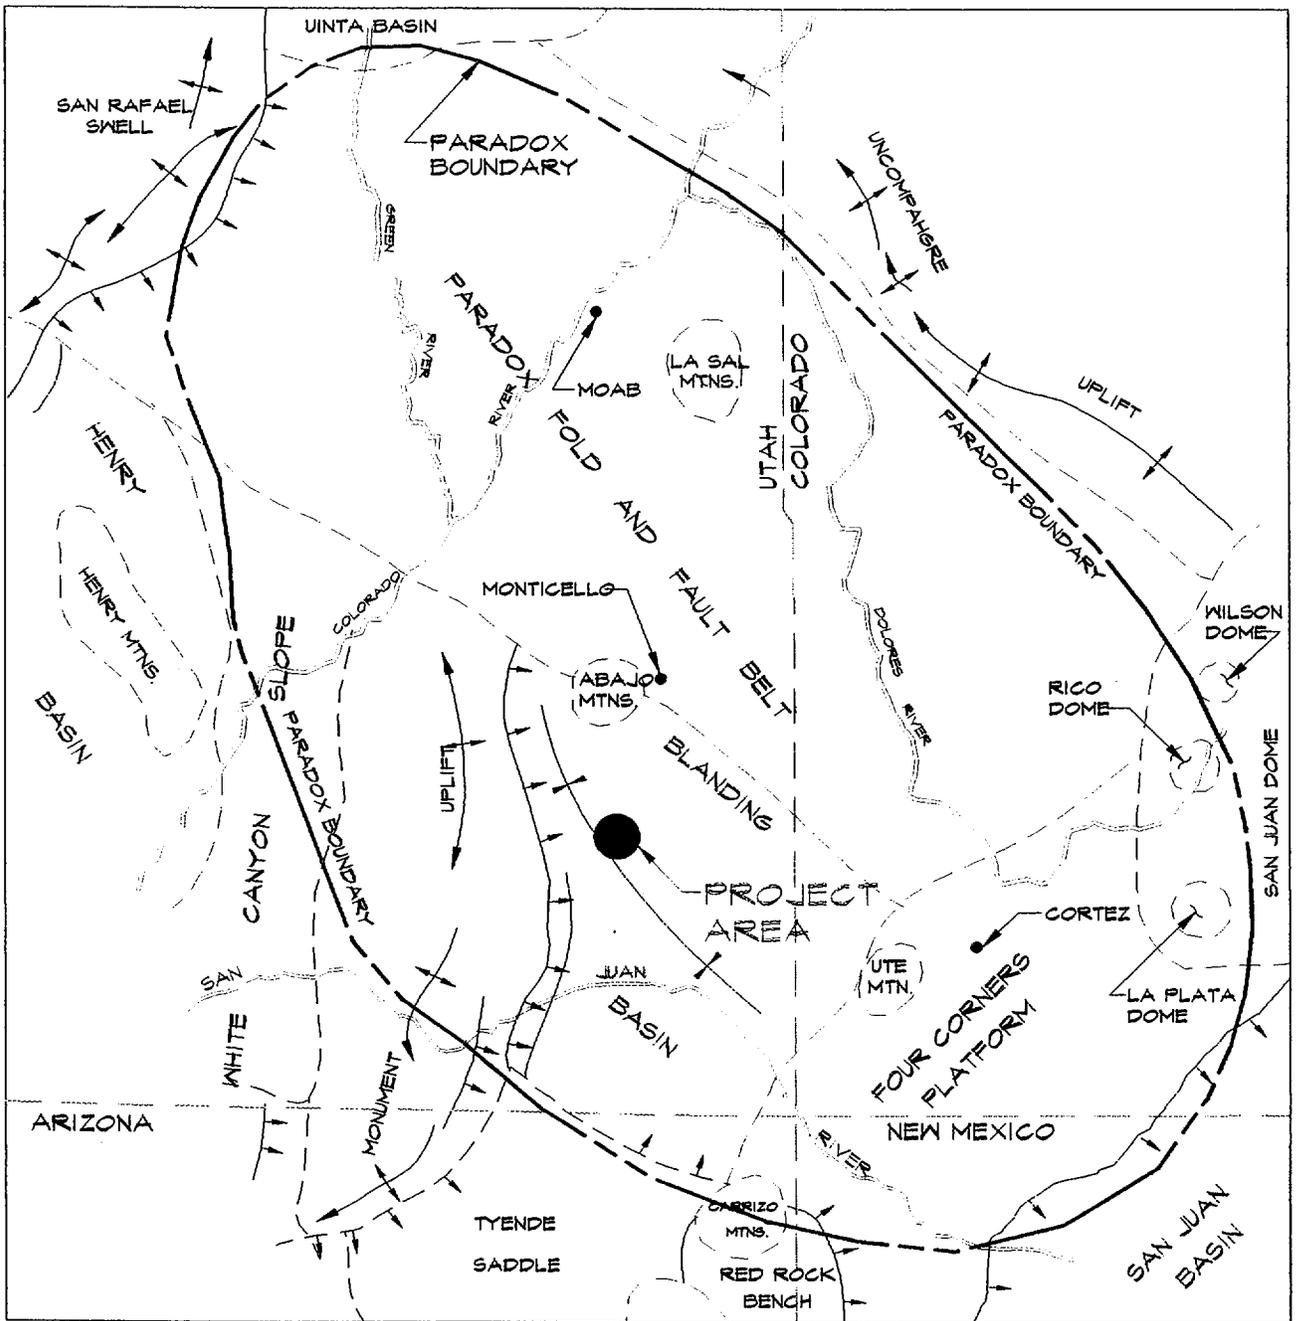
FIGURE 1.6.1
Tectonic Index Map

- BOUNDARY OF TECTONIC DIVISION
- MONOCLINE SHOWING TRACE OF AXIS AND DIRECTION OF DIP
- ANTICLINE SHOWING TRACE OF AXIS AND DIRECTION OF PLUNGE
- SYNCLINE SHOWING TRACE OF AXIS AND DIRECTION OF PLUNGE

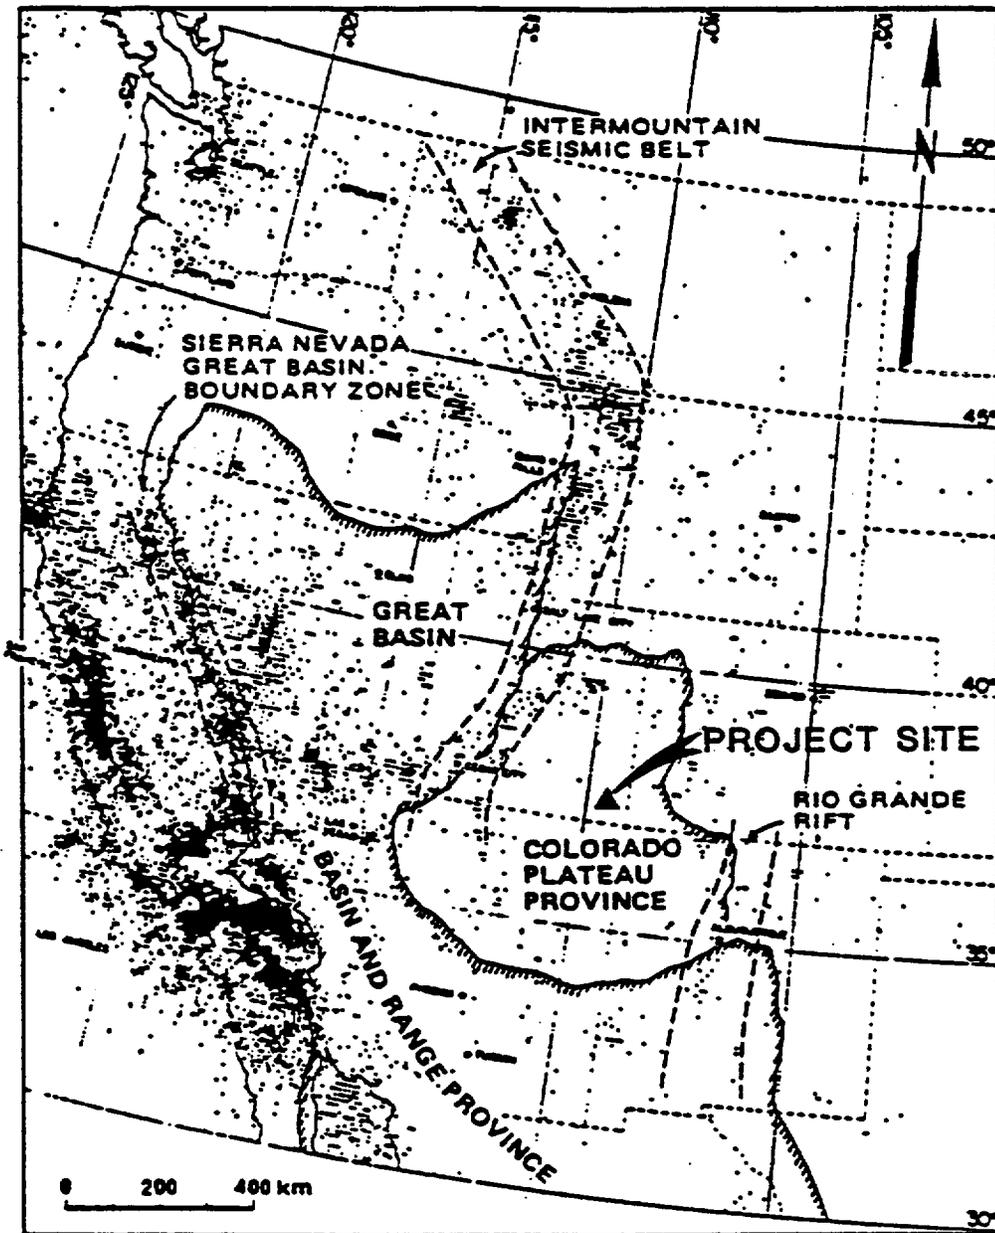
International Uranium (USA) Corporation White Mesa Mill		
FIGURE 1.6-5 Seismicity of the Western United States 1950 to 1976		
DESIGN:	DRAWN: RAH	SHEET
CHKD BY:	DATE: MAY, 1999	
APP:	SCALE: AS SHOWN	of

**SHOWS RELATIONSHIP OF THE COLORADO
PLATEAU PROVINCE TO MARCANAL BELTS**
