Re: Revision 3.0 to White Mesa Mill Reclamation Plan
License No. SUA-1358
Docket No. 40-8681

Reclamation Plan White Mesa Mill Blanding, Utah

Source Material License No. SUA-1358

Revision 3.0

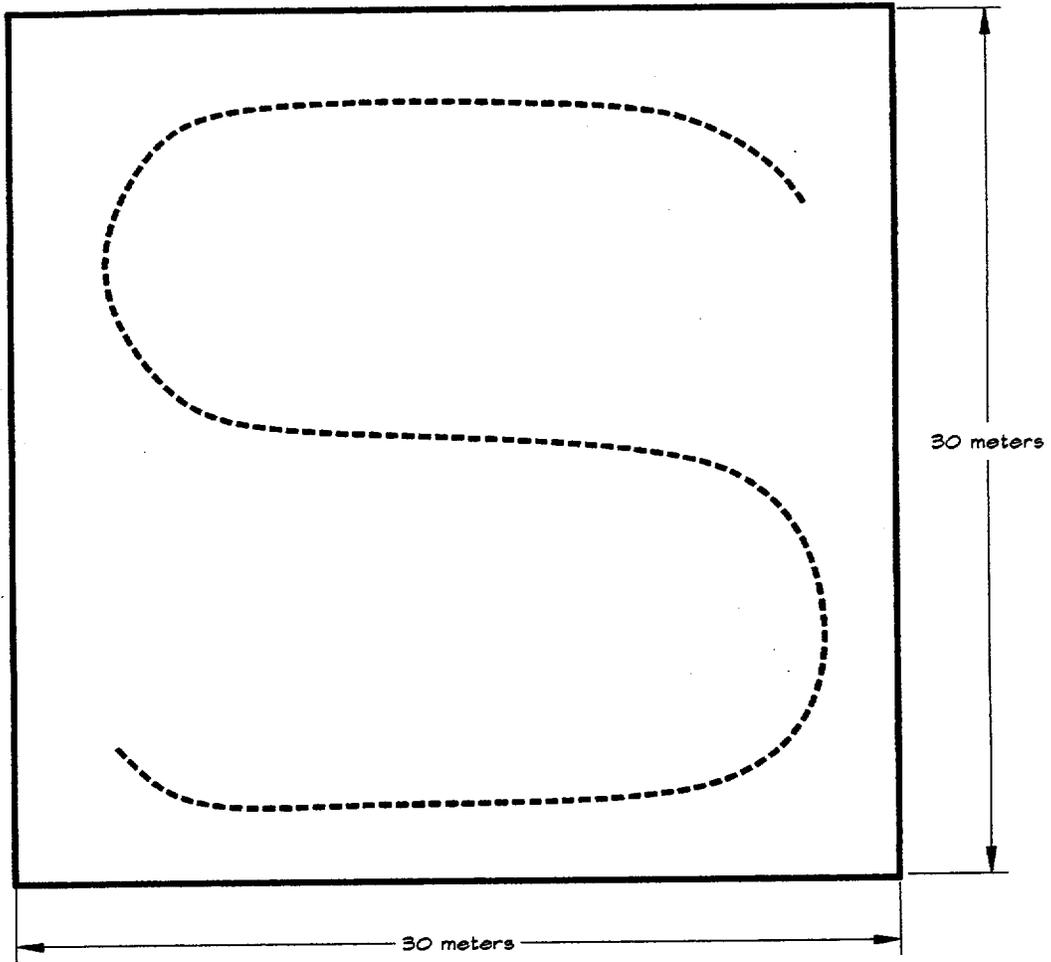
FIGURE A-3.3-1
TYPICAL SCANNING PATH
SCOPING SURVEY

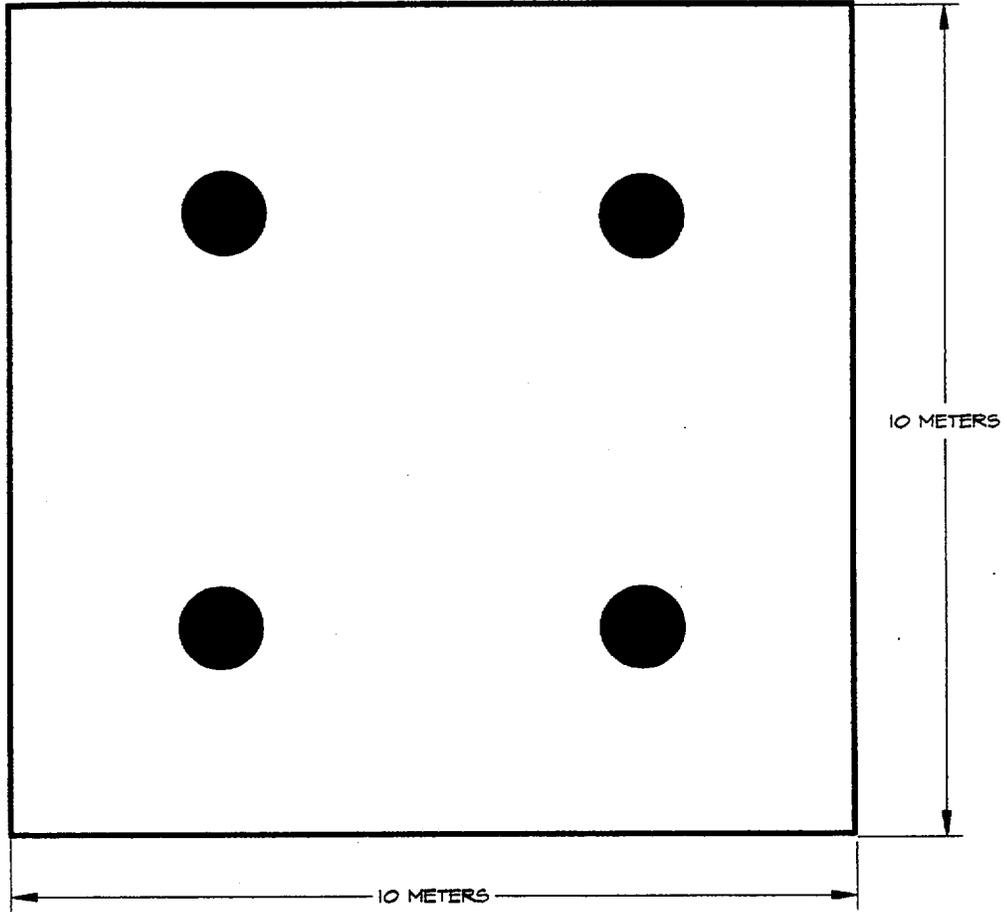
FIGURE A-3.3-2
STANDARD SAMPLING PATTERN FOR
SYSTEMATIC SURVEY OF SOIL

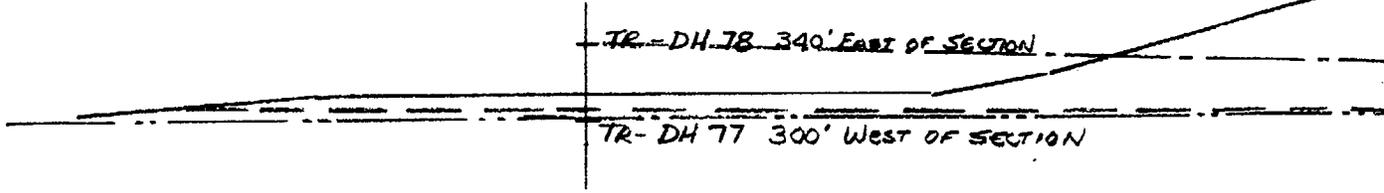
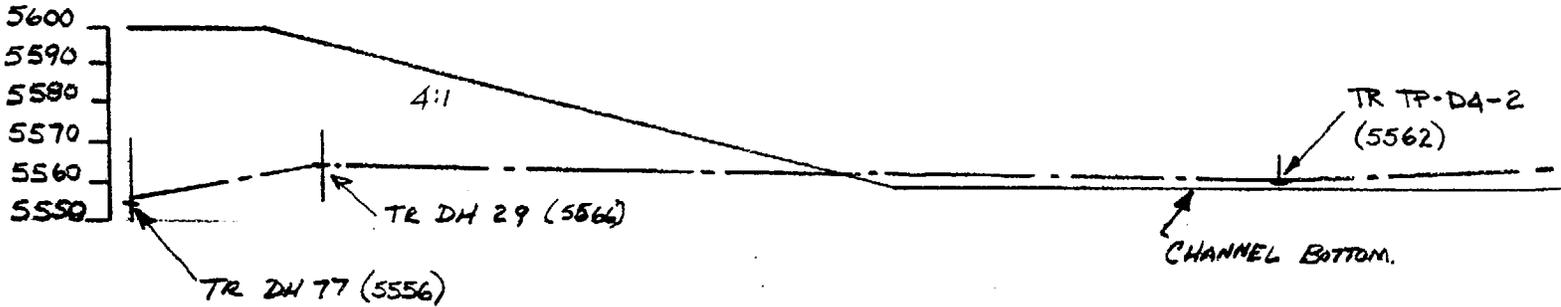
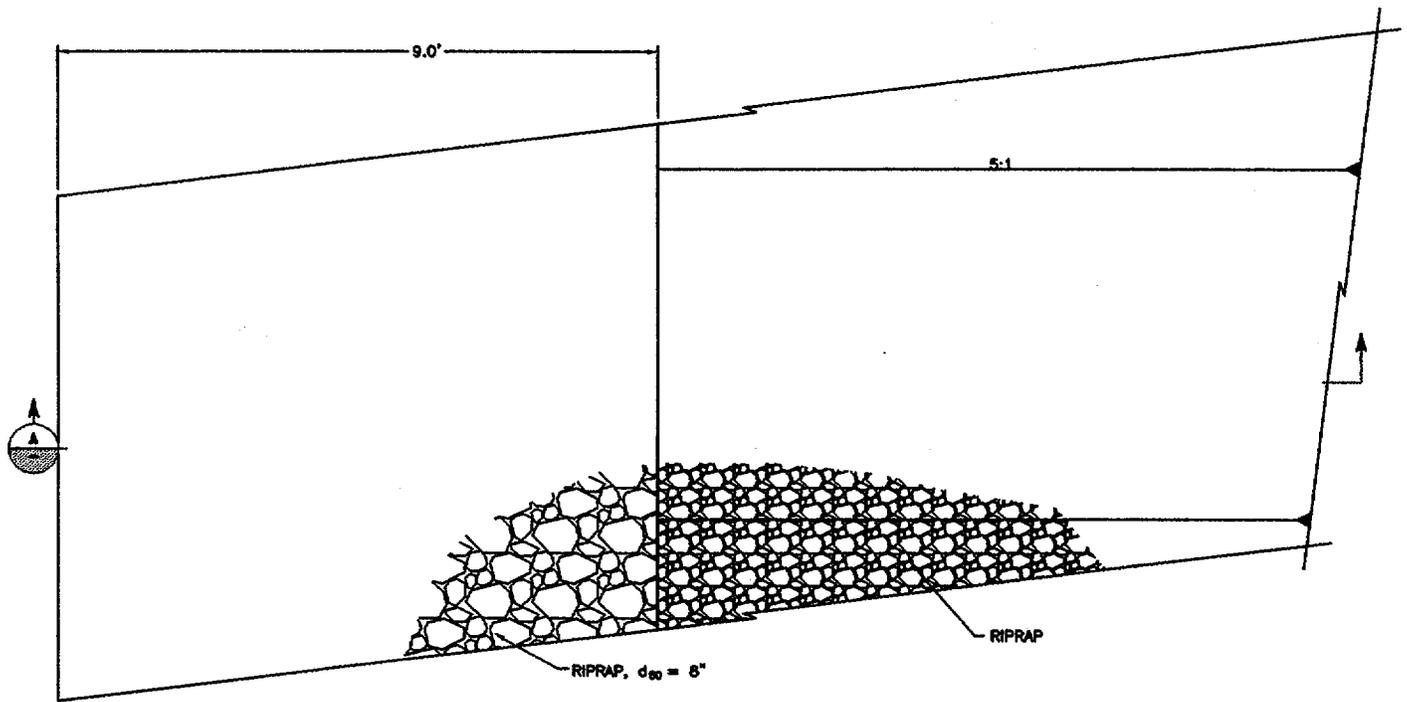
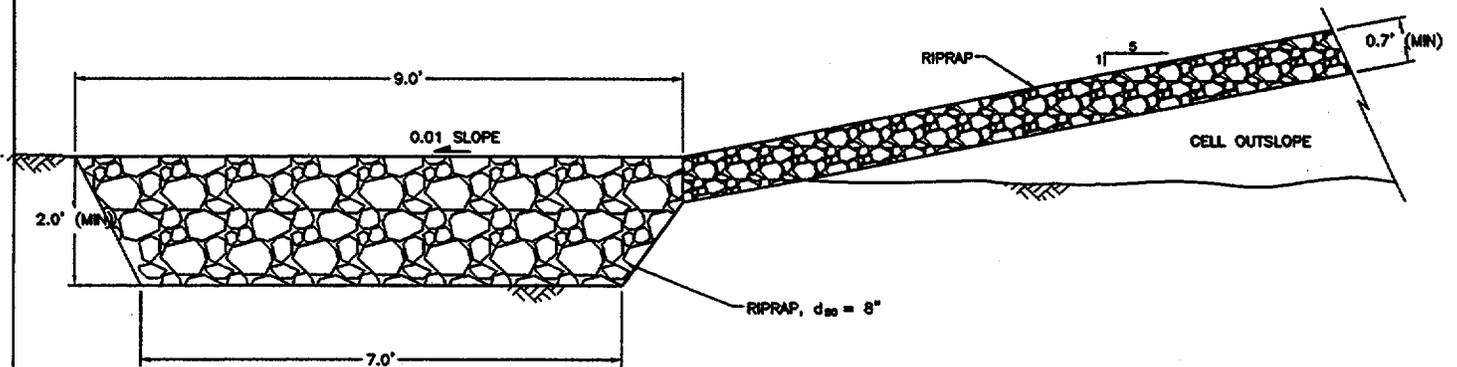
FIGURE A-5.1-4
Rock Apron at Base of Toe of Cell Outslope
