WHITE MESA URANIUM MILL

LICENSE RENEWAL APPLICATION

STATE OF UTAH RADIOACTIVE MATERIALS LICENSE No. UT1900479

**Volume 3 of 5
(License Renewal Application)
(Appendices J-O)**

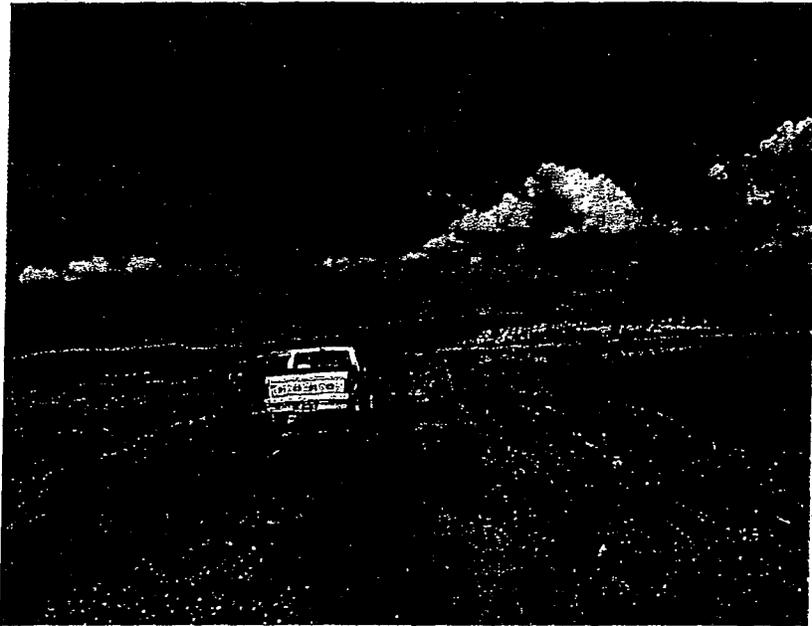
Photo 3. Crest of Dike 3 looking west.

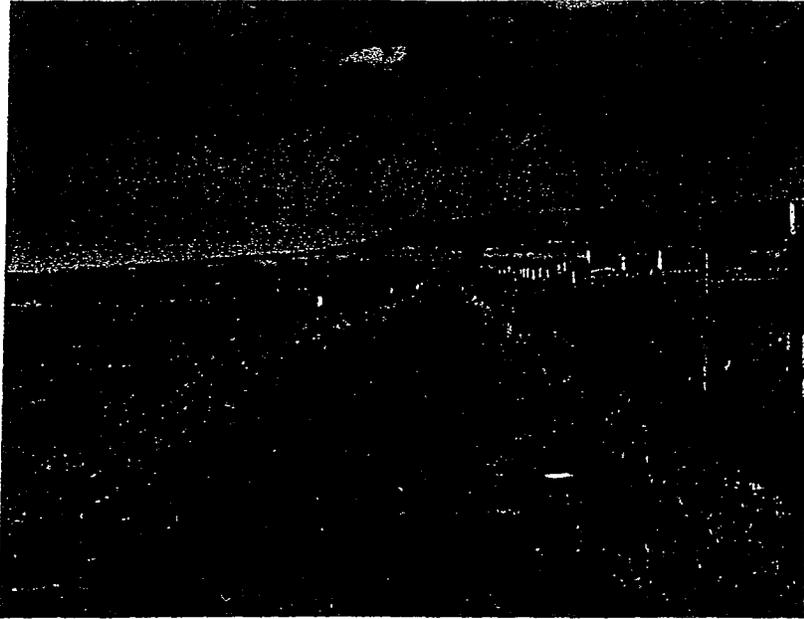
Photo 5. Crest of Dike 4A-S looking west.

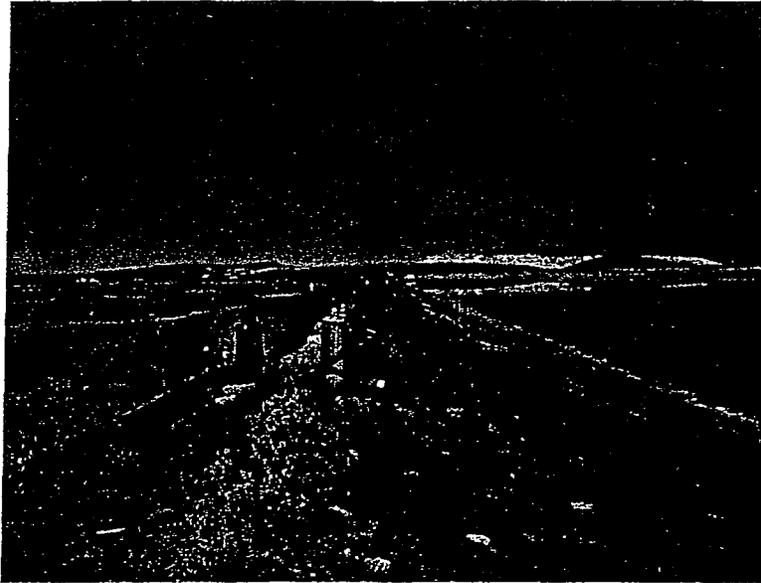
Photo 7. Dike 1 US slope.

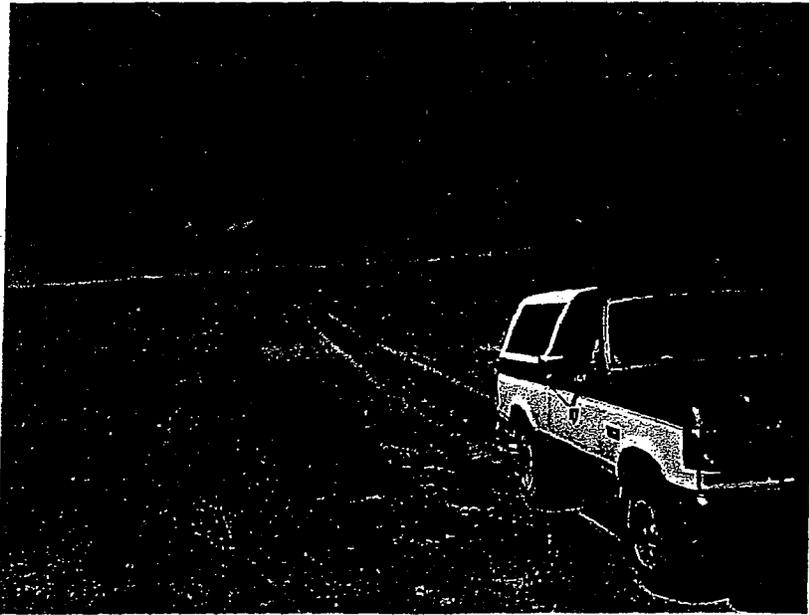
4-A is inoperable and cannot hold liquids or mill tailings, the safety or safe operation of Dikes 4A-E, 4A-S, and 4A-W is not an issue. Even though Cell 4A is not operable, Dikes 4A-E, 4A-S, and 4A-W were inspected for conditions that are indicative of distress and to assess the need for maintenance. No conditions or evidence of instability or distress such as slumping, cracking, seepage, or deformations were observed during the inspection. The dikes appear to be in good condition. The crests appear relatively level and straight with no evidence of visible settlement nor cracks indicating distress in the embankment (Photos 1 - 6). Inspection of the upstream and downstream side of the crest revealed no misalignment, cracking, or settlement (Photos 7 - 12). Upstream and downstream slopes were relatively uniform with no visible evidence of bulging, slumping, or signs of distress (Photos 7 - 12). The upstream slope of Dike I-1 had some evidence of beaching/wave erosion of the protective soil layer covering the liner (Photo 13). The beaching/wave erosion of the soil liner did not expose the liner. The licensee was informed to monitor and repair the beaching/wave erosion before the liner is exposed. The right abutment groin of Dike 3 and the contact area between Dike 3 and 4A-W were dry with no evidence of seeps or wet areas (Photos 9 & 14). The downstream toes of Dikes 3, 4A-E, 4A-S, and 4A-W were dry with no evidence of wet areas or seeps (Photos 9 - 11).

Photo 10. DS slope & toe of Dike 4A-E.

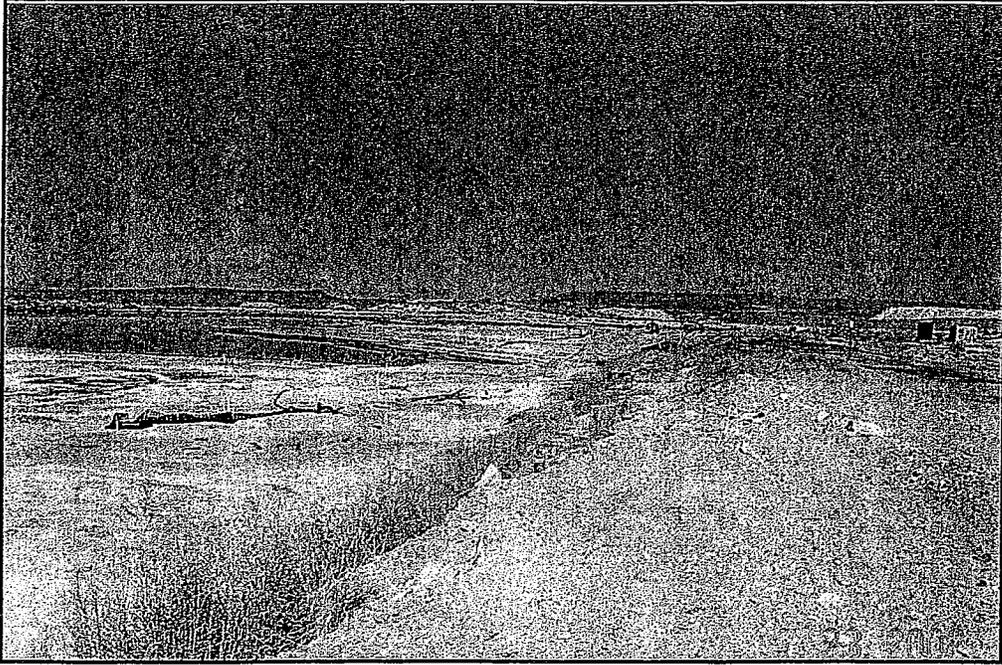
Photo 5. Looking west near center of Dike 2. Liquids in Cell No. 3 on the left. The spillway section between Cell Nos. 2 and 3 is in the right center of the photograph.

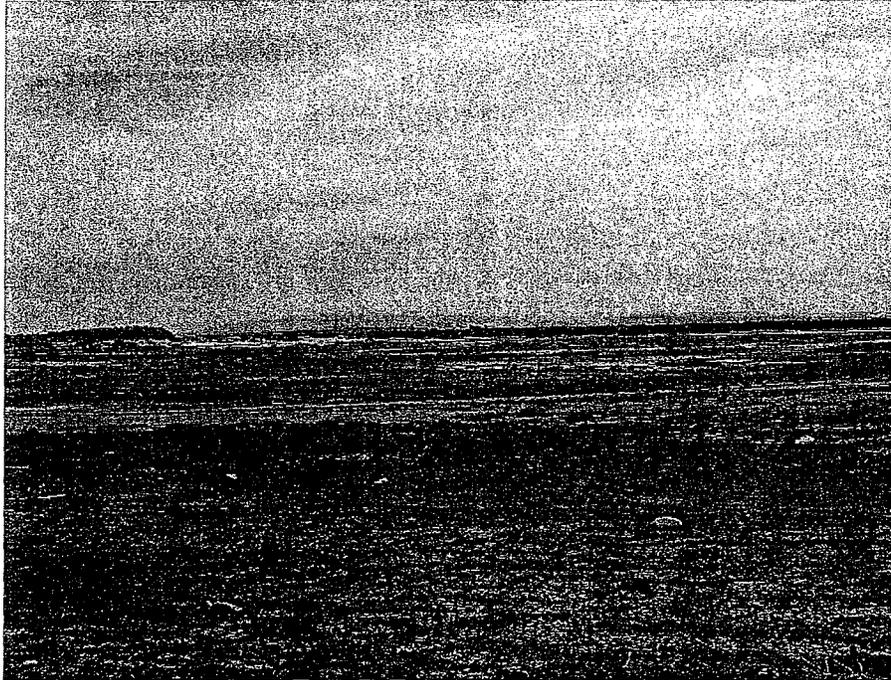
Figure 3: March 22, 2005: Cell 2 viewed from the north embankment. Temporary radon barrier has been placed over the majority of the cell.

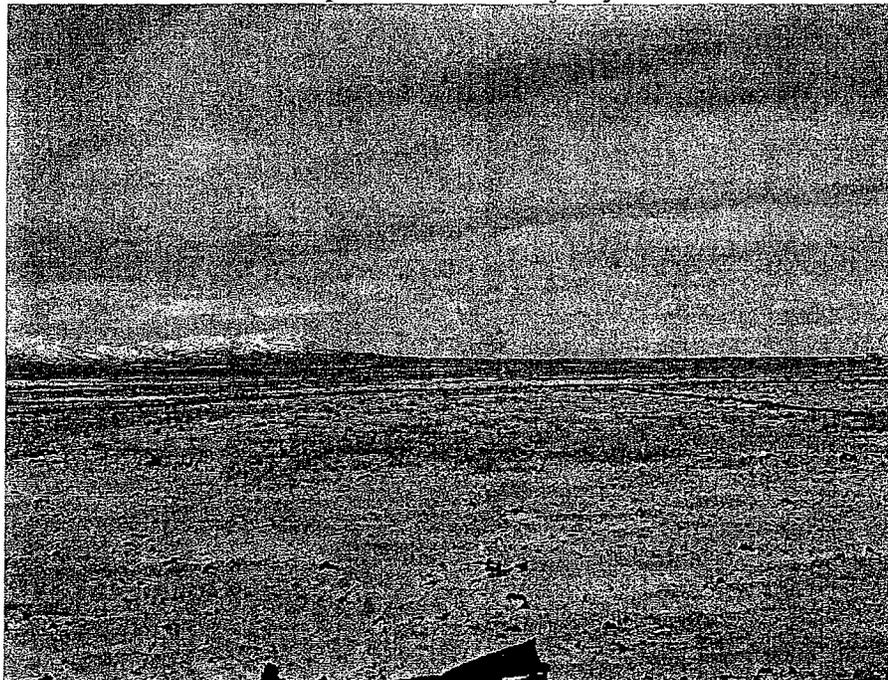
Figure 4: March 22, 2005: Cell 2 viewed from the south embankment. Temporary radon barrier has been placed over the majority of the cell.

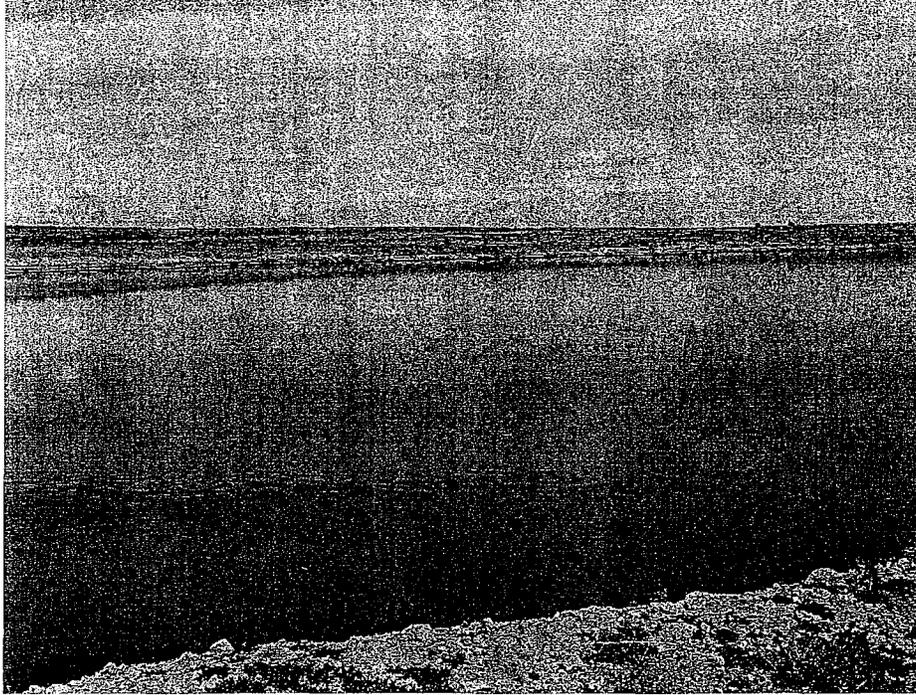
Figure 1: 03/22/05: View of Cell 1 from the north embankment. The band of red is the freeboard of the cell.

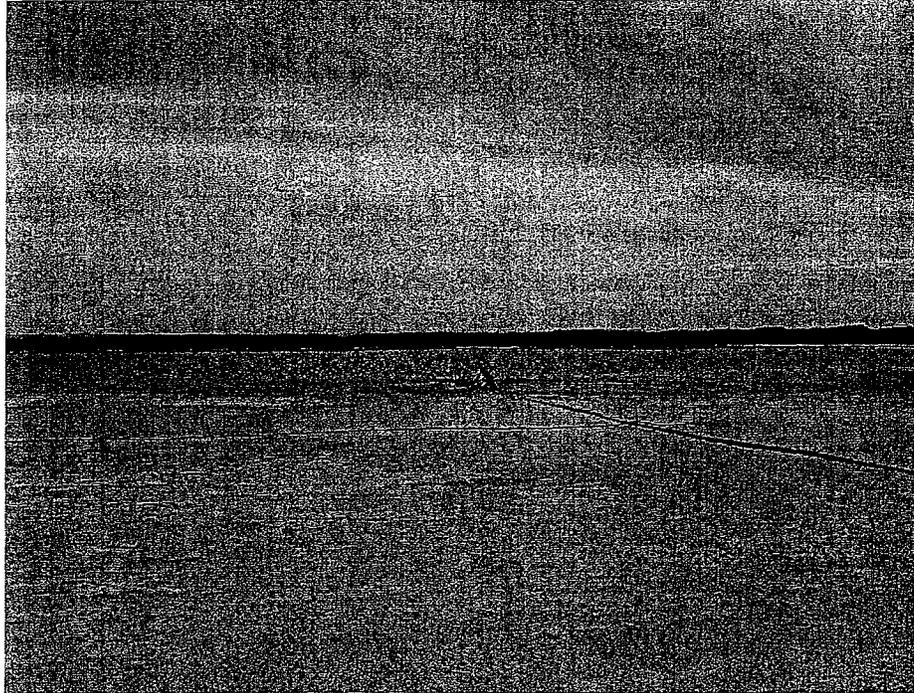
Figure 7: March 22, 2005: Cell 3 salt crust over tailings sands and pool viewed from north embankment. The salt crust is the white/gray in the foreground.

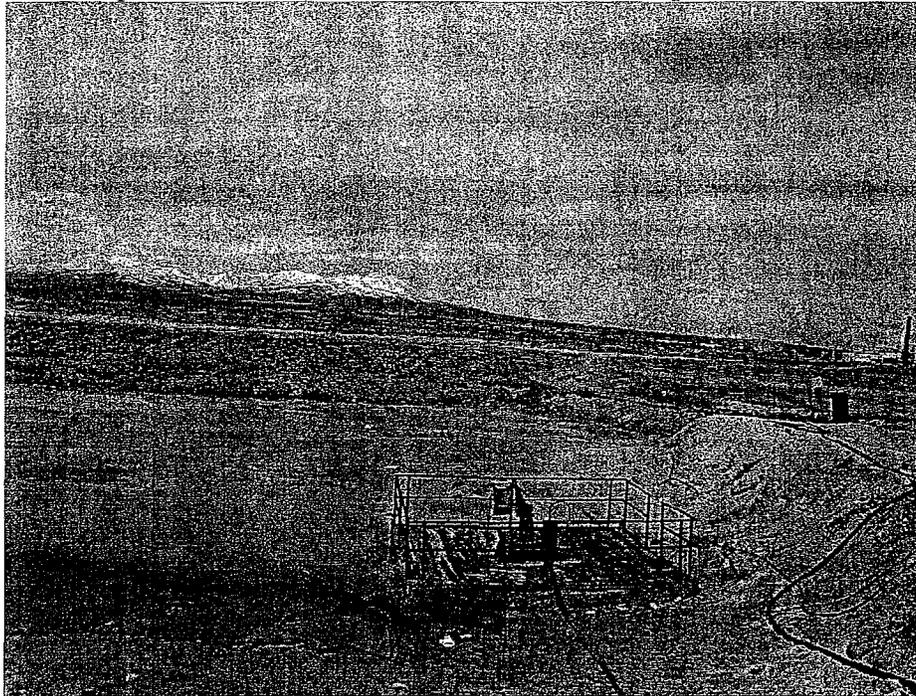
Figure 5: March 22, 2005: Open area of Cell 2 viewed from the south embankment.
This portion of the cell is used for facility trash disposal.

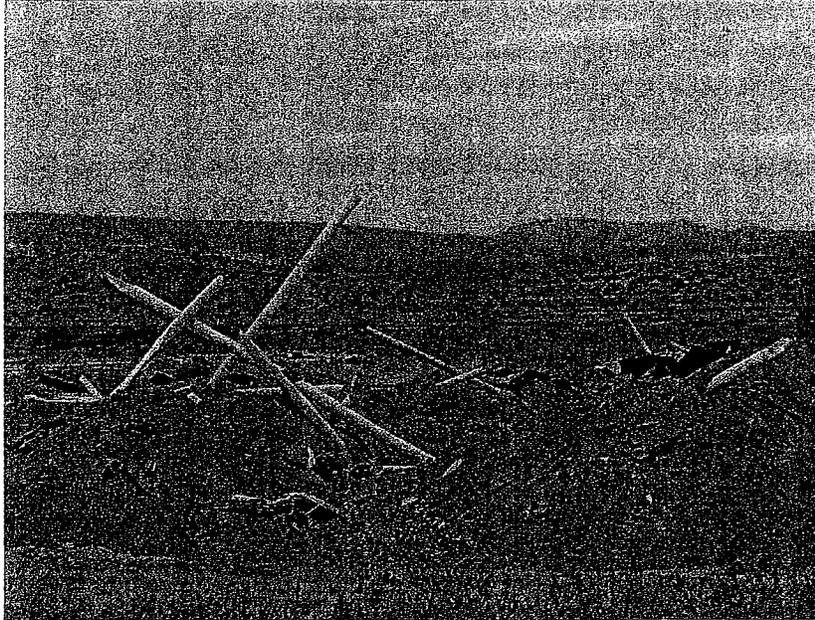
Figure 1: 09/20/05: Cell 4A Leak detection system has been cleaned up and is waiting for final disposal in tailings Cell 3.
